Ely & District Archaeological Society

# A SURVEY OF STONE WALLS IN ELY

Sections I -V Complete

# **SURVEY OF WALLS IN ELY**

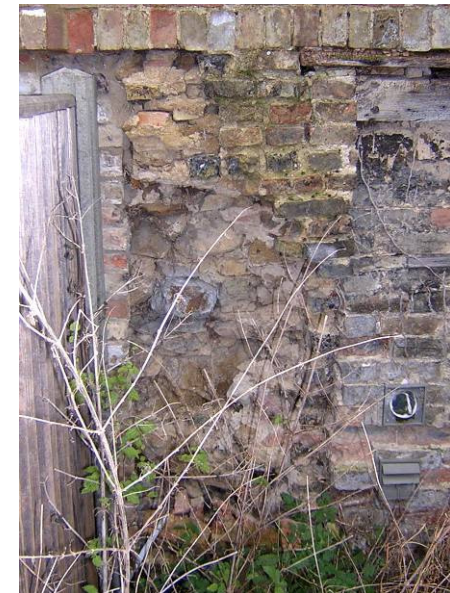
VIEW OF WALL 6

The face of the wall has deteriorated (assuming it was a face and not a broken end section) and has exposed a coarse construction with a large proportion of mortar.

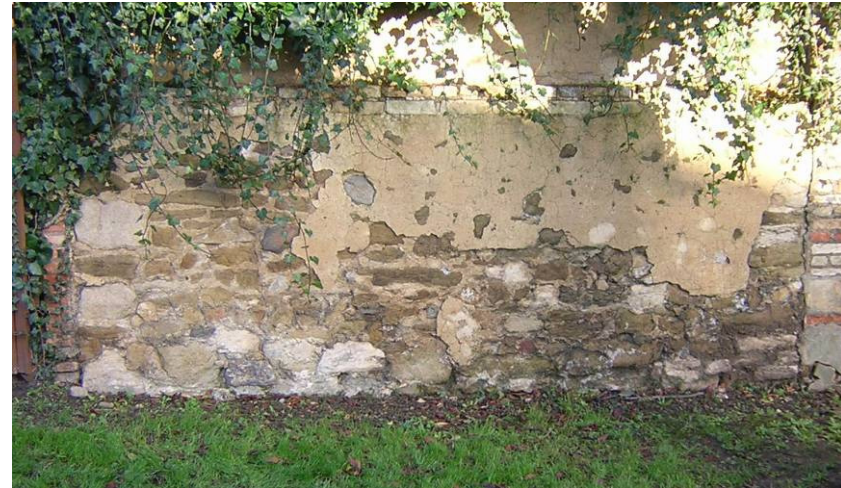
**VIEW OF WALL 8**

Approximately 40% of the stonework is hidden by rendering  
The adjacent section of wall (to right of photo) has stone at low level, but is painted and thus the extent of stone is not clear.

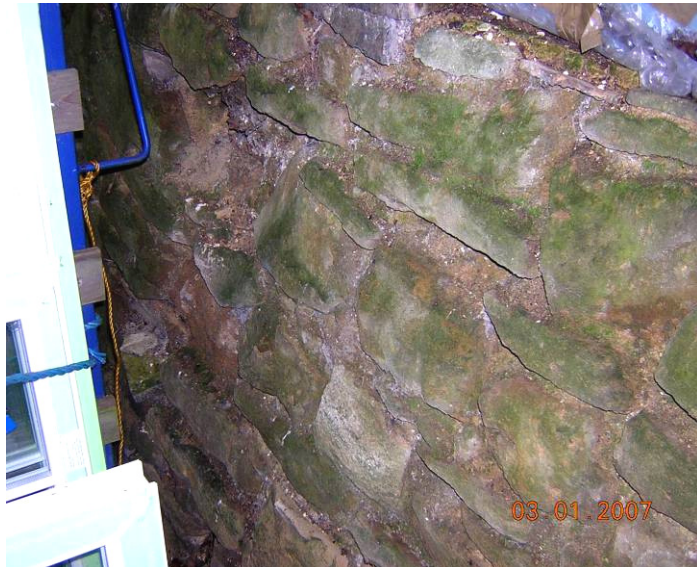
**A SMALL SECTION OF WALL 13****SECTION I: WALL NUMBER 14**

70% of the wall is hidden by builder's/shop fitter's equipment. This prevented clear vision and also access to the face of the wall to take measurements. Visible portions are covered in green moss.

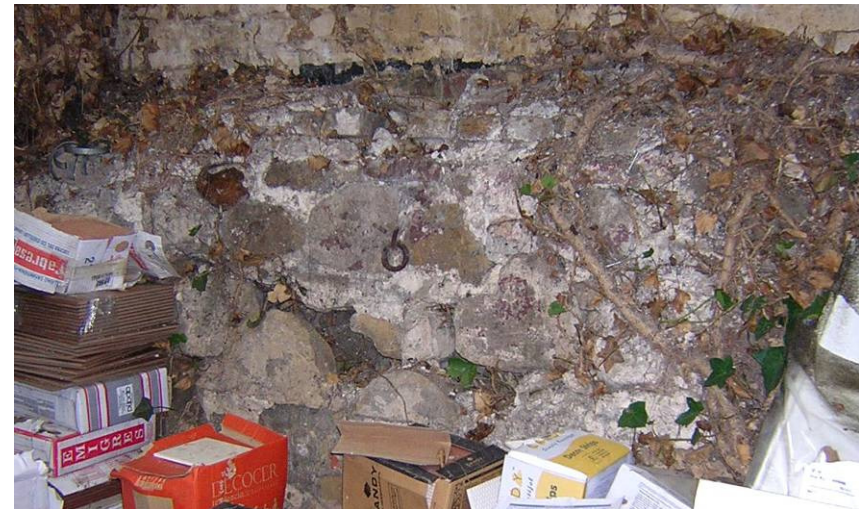
**A SMALL SECTION OF WALL 14**

Measurements could not be taken in close proximity to the wall and thus the measurements lack accuracy. Over 90% of the wall was hidden by stored items.

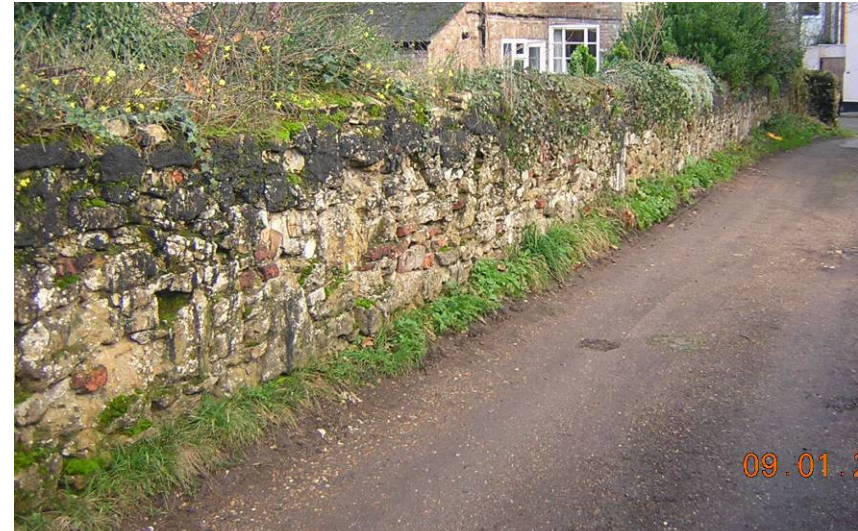
**VIEW OF PART OF WALL 16**

Approximately half the length (east end) of the wall has had a coating of tar on the upper stones.

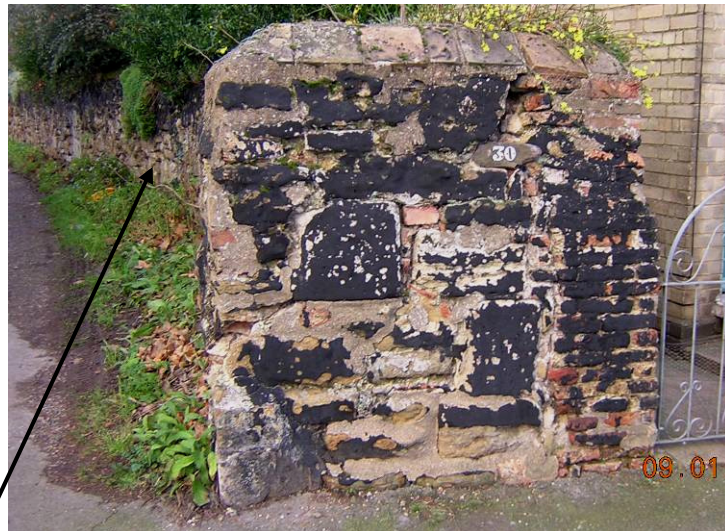
VIEW OF WALL 17

Identification of the stone was hindered by a coating of bitumen.

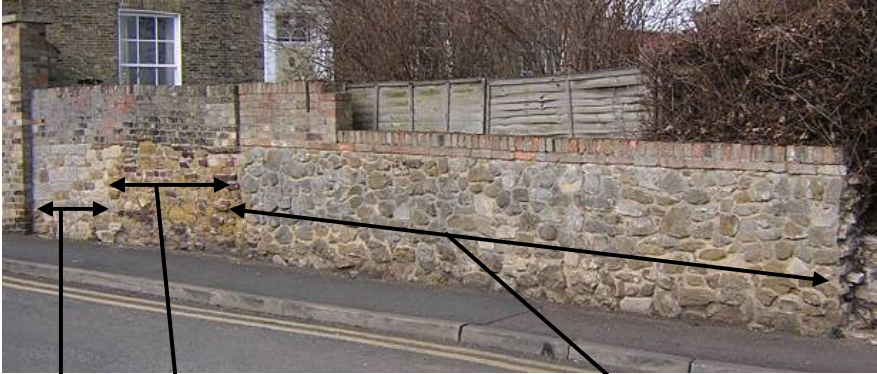
<p>Section A      Section B      Section C</p>																		
<b>VIEW OF WALL No 1</b>

SECTION II : WALL NUMBER 1		Date Surveyed March 2006																
<b>Location/General Description</b> In The Vineyards. The south wall of 21 Market Place, also known as Vine Yard Lodge.																		
<b>Construction</b> Length A: Ashlar of irregular size with 8 courses of brick on top including a course of brick on edge to form a coping. B: Random rubble with brick on top, as section A. C: Random rubble topped with 2 courses of brickwork including a course of brick on edge to form a coping.																		
<b>Composition</b> Length A: 50% Barnack limestone (mainly rag), including 2 large stones, 30 % local sandstone and three granite blocks. Length B: 70 % local sandstone, 30 % brick, including some clay tiles. Length C: 95% local sandstone, 5% miscellaneous including Barnack limestone.	<b>Dimensions in meters</b>

A	B	C	Length:	1.81	2.06	8.00	Height :	1.78	1.82	1.37	Thickness:	not known	0.40	
	A	B	C															
Length:	1.81	2.06	8.00															
Height :	1.78	1.82	1.37															
Thickness:	not known	0.40																
<b>Comments</b> The wall thickness was measured at one end where the wall was fractured and the cross-section made visible. The height of the stonework portion within the wall was reasonably constant at 1.1 to 1.2 m.

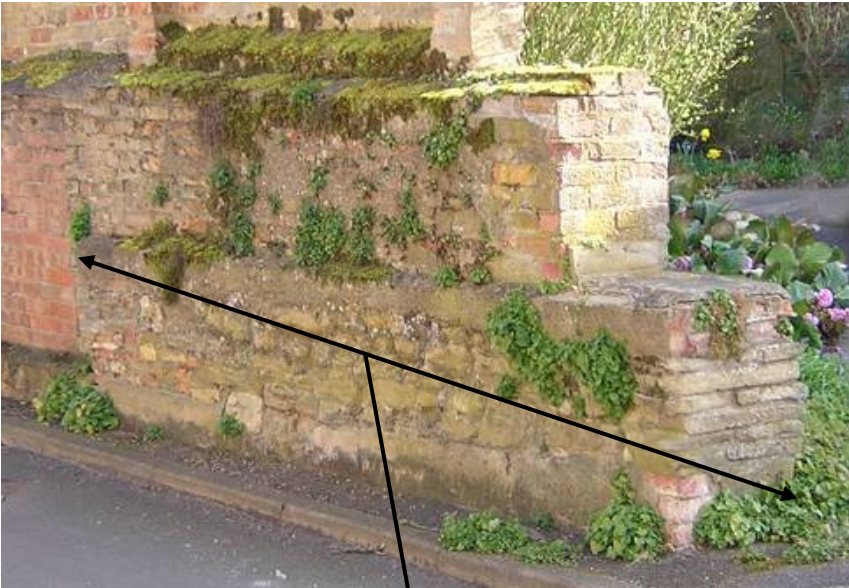
<p style="text-align: center;"><b>Stonework portion</b></p> <p style="text-align: center;"><b>VIEW OF WALL No 3</b></p>

<b>SECTION II : WALL NUMBER 3</b>		<b>Date Surveyed</b> March 2006
<b>Location/General Description</b> Springhead Lane. The wall forms the north-east boundary of No 4		
<b>Construction</b> The wall is of brick construction with a small section of stonework. The stonework is random rubble with rough coursing.		
<b>Composition</b> The stone is 95% local sandstone and 5% Barnack rag.	<b>Dimensions in meters of the stonework portion</b> Length: 2.62  Height: 0.67  Thickness: 0.40	
<b>Comments</b> This wall is on the same alignment as wall No 2.

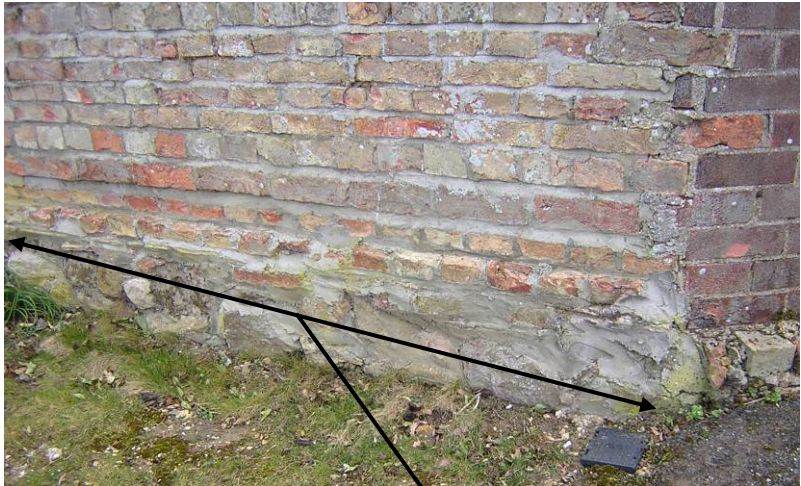
<p style="text-align: center;"><b>Stonework portion</b></p> <p style="text-align: center;"><b>VIEW OF PART OF WALL No 4</b></p>

<b>SECTION II : WALL NUMBER 4</b>		<b>Date Surveyed</b> March 2006
<b>Location/General Description</b> Springhead Lane. The wall forms the north-east boundary of No 22.		
<b>Construction</b> The wall is of brickwork, founded on stone. The stone above ground level is randomly placed.		
<b>Composition</b> Various stone types.	<b>Dimensions in meters of stonework portion</b>  Length: 5.6  Height: 0.25  Thickness: 0.47	
<b>Comments</b>

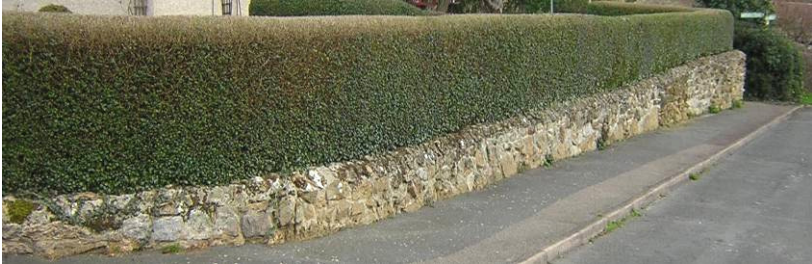
<p style="text-align: center;"><b>GENERAL VIEW OF WALL No. 5</b></p>

<b>SECTION II : WALL NUMBER 5</b>		<b>Date Surveyed</b> March 2006
<b>Location/General Description</b> Springhead Lane. The wall forms the south-west boundary of No 45.		
<b>Construction</b> Random rubble. A coping has been shaped from small flat stones and mortar.		
<b>Composition</b> 95% local sandstone, 5% miscellaneous including Barnack limestone (rag and oolitic), brick fragments, and some concrete.	<b>Dimensions in meters</b>  Length: 23.5  Height: 0.3 to 1.25  Thickness: 0.50	
<b>Comments</b> The top of the wall appears level and the height increases as the ground level falls. As the wall acts as an earth retaining wall the inner face could not be inspected and thus the thickness can only be determined in limited areas.

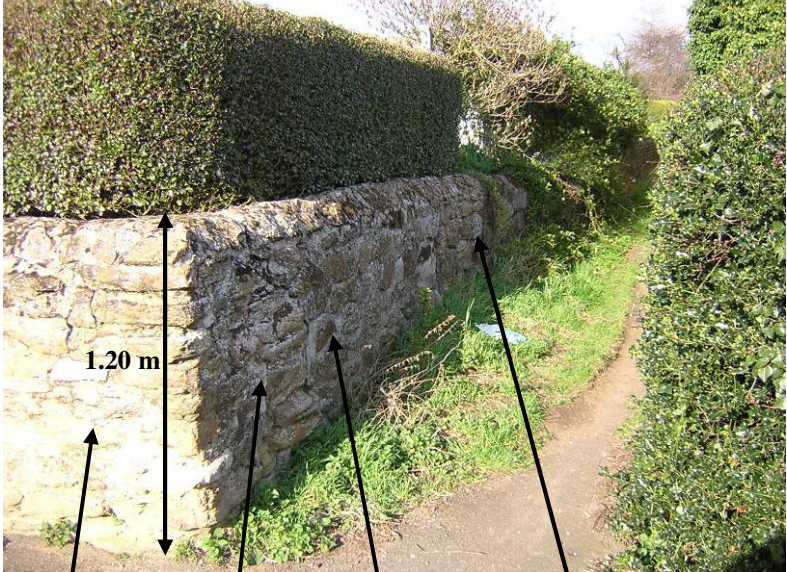
<p style="text-align: center;"><b>OBLIQUE VIEW OF WALL No 6</b></p>

<b>SECTION II : WALL NUMBER 6</b>		<b>Date Surveyed</b> March 2006
<b>Location/General Description</b> Commences in Springhead Lane and follows the path of the Nature Trail. It is bonded at right angles to wall No 5 and forms the south-east boundary of No 45.		
<b>Construction</b> There are three sections all of random rubble. The coping is as described for wall No 5.		
<b>Composition</b> Section a: local sandstone Section b: local sandstone plus one brick. Section c: 30 % local sandstone, 20% broken concrete, 50 % miscellaneous including Barnack rag, granite sets, granite blocks, bricks and other stone fragments. The wall contains some large stones.	<b>Dimensions in meters</b>  Length: 14.02  Height: 0.83 to 1.20  Thickness: 0.40	
<b>Comments</b> The wall acts as an earth retaining wall. The coping detail is identical to wall No 5. Vegetation makes it difficult to assess the composition of section C.

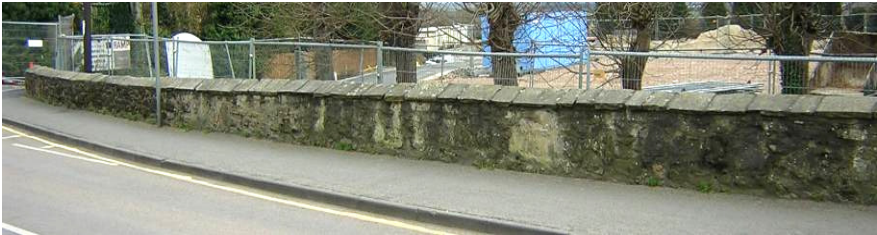
<b>VIEW OF WALL No 7</b>

<b>SECTION II : WALL NUMBER 7</b>		<b>Date Surveyed</b> March 2006
<b>Location/General Description</b> Prickwillow Road. The NW wall to No.s 1-4 Douglas Court (a building site at the time of the inspection).		
<b>Construction</b> Random rubble topped with 5 cm thick sandstone slab coping.		
<b>Composition</b> External face: 95% local sandstone, 5% brick.  Inner face: Local sandstone with significant proportion of brickwork. Some areas partially rendered and some roughly coursed.	<b>Dimensions in meters</b>  Length: 23.65  Height: NW face 0.53 to 0.69 SE face 1.52 to 1.66 Thickness: 0.25 to 0.30	
<b>Comments</b> Access to the inner face could not be obtained, but it was partially viewed obliquely from adjoining property.

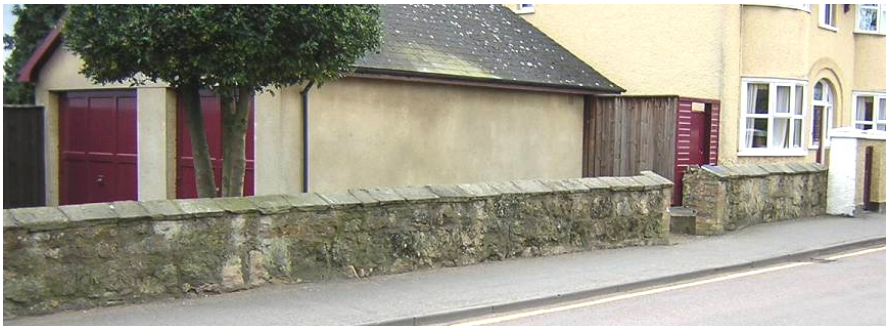
<b>VIEW OF WALL No 8</b>

<b>SECTION II : WALL NUMBER 8</b>		<b>Date Surveyed</b> March 2006
<b>Location/General Description</b> Prickwillow Road. Wall to north of No 48.		
<b>Construction</b> Random rubble with some rough coursing. The coping is formed as for wall 7.		
<b>Composition</b> Outer face: 100 % sandstone. Inner face 80 % sandstone. 20 % brick.  Note the stone blocks are variable in colour and texture, but are probably all local sandstone.	<b>Dimensions in meters</b>  Length: 14.6 m  Height: 0.74 to 0.79  Thickness: 0.30	
<b>Comments</b> The inner and outer faces of the wall were inspected. Walls 7 and 8 are separated by an opening, and border different properties, but otherwise wall 8 is a continuation of wall 7.

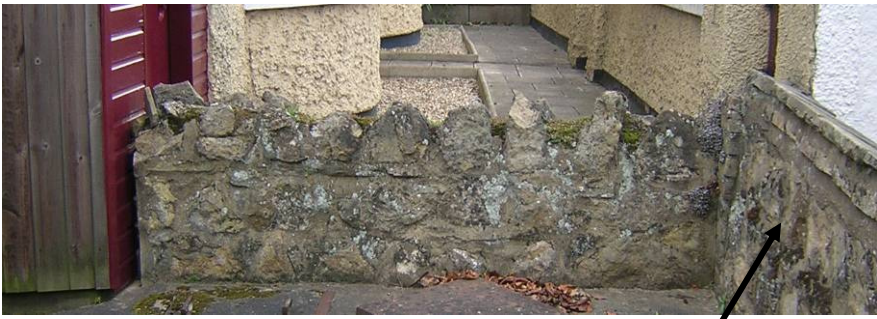
<p style="text-align: center;">Inner face of wall No 8</p>		
<b>VIEW OF WALL No. 9</b>

<b>SECTION II : WALL NUMBER 9</b>		<b>Date Surveyed</b> March 2006
<b>Location/General Description</b> The wall is within the property of 48 Prickwillow Road, and is at right angles to wall 8.		
<b>Construction</b> Random rubble. There is no coping.		
<b>Composition</b> 100 % sandstone.  Note the stone blocks are variable in colour and texture, but are probably all local sandstone.	<b>Dimensions in meters</b>  Length: 2.45 Height: 0.75  Thickness: 0.30	
<b>Comments</b> Wall 9 butts against wall 8.

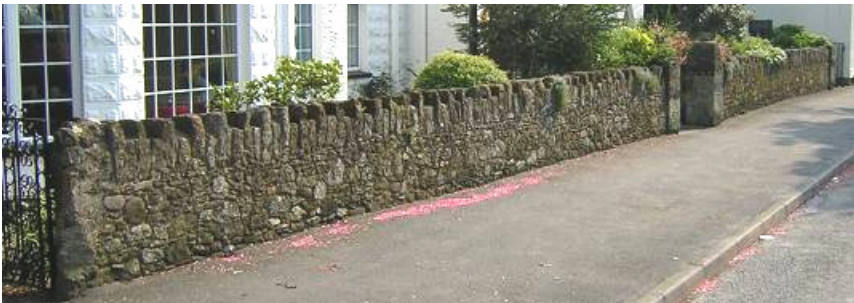
<b>VIEW OF WALL No 11</b>

<b>SECTION II : WALL NUMBER 11</b>		<b>Date Surveyed</b> April 2006
<b>Location/General Description</b> New Barns Road. The wall forms the west boundary of No 50, The Castle Lodge Hotel		
<b>Construction</b> Random Rubble with a crenellated top.		
<b>Composition</b> 25 % Barnack Limestone 70 % sandstone, predominantly local. 5 cobbles, including flint. 1 concrete block. There are 3 gate posts constructed with concrete blocks and containing some small sandstone infills between the blocks.	<b>Dimensions in meters</b>  Length: 23.6  Height: 1.0 to 1.03  Thickness: 0.35	
<b>Comments</b>

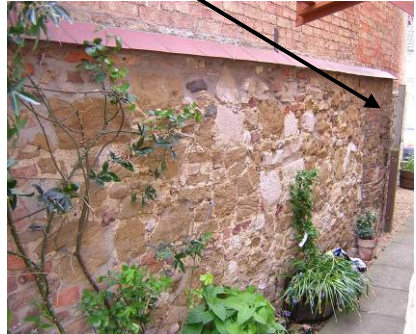
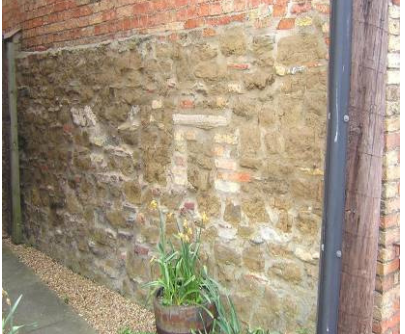
<b>Section C</b>	
<b>Section A</b> <b>Section C</b> <b>VIEWS OF WALL No 12</b>

<b>SECTION II : WALL NUMBER 12</b>		<b>Date Surveyed</b> May 2006
<b>Location/General Description</b> The wall forms part of the north gable wall of 41 Waterside.		
<b>Construction</b> The wall can be divided into three areas; a, b and c from east to west. (a) and (c) are random rubble (b) is predominantly brickwork and thus laid in courses.		
<b>Composition</b> Material/Sections	<b>Dimensions in meters</b> Sections <u>A</u> <u>B</u> <u>C</u> Length: 4.45 0.95 4.70  Height: 1.74 1.89 1.75  Thickness: not known	
Local sandstone 40%	A B C 30% 80%	
Barnack Rag 40%	0 10%	
Brick (pre 1725) 20%	60% 10%	
Section A also has some basalt and 4 quartzite cobbles and 3 flints. Section B also has 10% of fine grained Barnack limestone. Section C has 2 large pieces of Barnack stone, one of which is carved and forms the lintel of a blocked up opening. There is another carved stone – see the comments.		
<b>Comments</b>

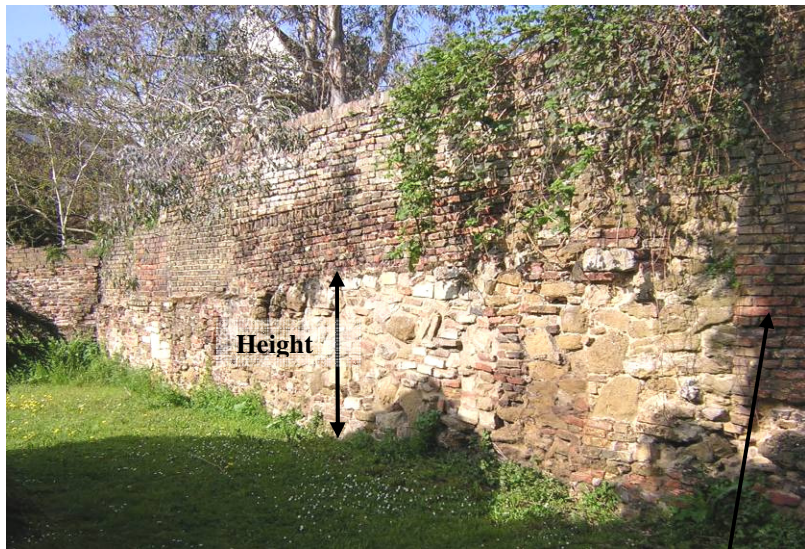
**VIEW OF WALL No 13**

**Comments**  
 The inner face of the wall was surveyed.  
 The wall contains some large stones of sandstone.

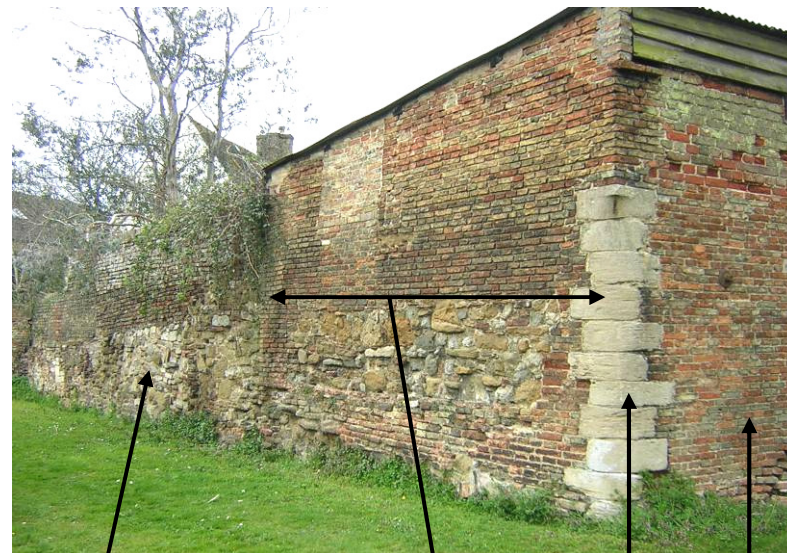
**Comments**  
 The wall contains some large stones of sandstone.

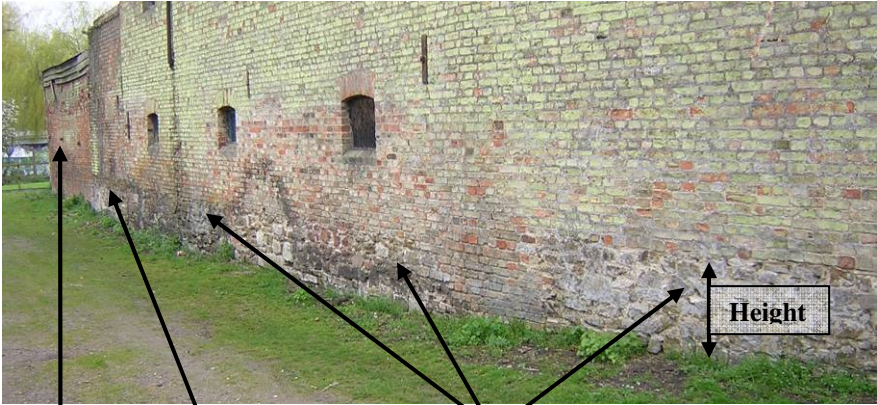
<p style="text-align: center;"><b>VIEW OF WALL No 15</b></p>

<b>Comments</b> Section B includes two large pieces of Barnack Rag.

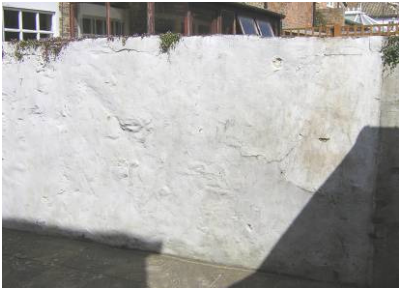
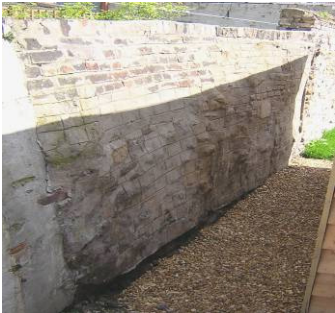
<b>Section A</b>	<b>Section B</b>

Thickness: A & B not known, C is approx 0.35		Sections	A	B	C	Length :	4.8	4.0	3.6	Height :	1.71	2.01	2.00
Sections	A	B	C											
Length :	4.8	4.0	3.6											
Height :	1.71	2.01	2.00											
<b>Comments</b> The inner face of the wall was surveyed.

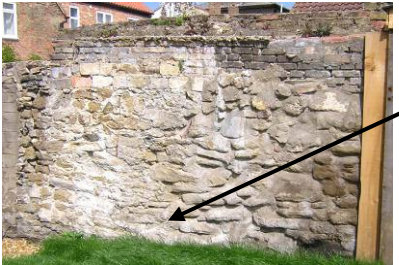
<p>Thickness: approx 0.40  Es = stonework portion of section E.</p>		Section	Length	Height min/max	A	7.08	1.3/1.6	B	9.35	1.4/1.7	C	7.98	1.6/1.8	D	10.20	1.7/1.9	E	9.90	1.2/1.5	Es	6.03	0/1.2
Section	Length	Height min/max																					
A	7.08	1.3/1.6																					
B	9.35	1.4/1.7																					
C	7.98	1.6/1.8																					
D	10.20	1.7/1.9																					
E	9.90	1.2/1.5																					
Es	6.03	0/1.2																					
<b>Comments</b> Under sections of the reconstructed wall, at ground level, older stones remain in place suggesting that the foundations have not been changed.

<p>There is a small portion of painted plaster adhering to the stone at the base of section C, suggesting that it used to be an internal face (e.g. an external toilet wall).</p>													
<b>Section C</b>														
<b>VIEWS OF WALL No 17</b>

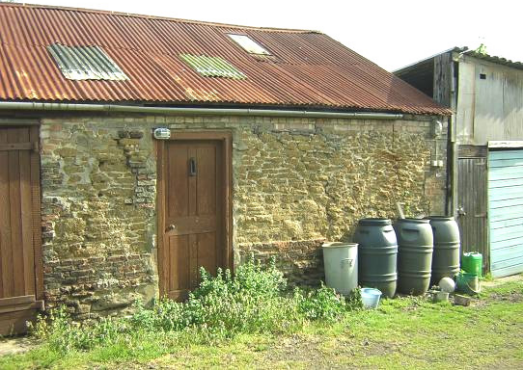
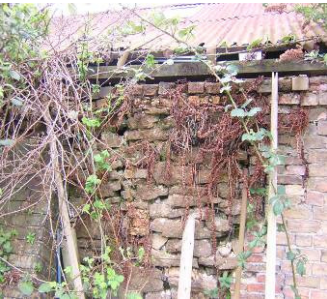
<b>Part of South Wall</b>		<b>Part of North Wall</b>
<b>VIEWS OF WALL No 18</b>

<b>SECTION II : WALL NUMBER 18</b>		<b>Date Surveyed</b> May 2006
<b>Location/General Description</b> Agricultural shed within smallholding to rear of 47 Waterside.		
<b>Construction</b> The west wall is brickwork. The east wall is obscured by a timber extension, and the north and south walls are brickwork and random rubble stonework.		
<b>Composition</b> North wall This is in a poor condition with the mortar severely eroded. It is a mixture of brick and stone portions with brick buttresses. There are a few large stones. South Wall The stone is 100% local sandstone. The lower courses of brick are pre 1725 size.	<b>Dimensions in meters</b> South wall measured: Length: 13.05  Height: 2.12  Thickness: Not known	
<b>Comments</b> The plan dimensions of the shed are 13.05 m by 6.48 m, excluding timber construction to the west.

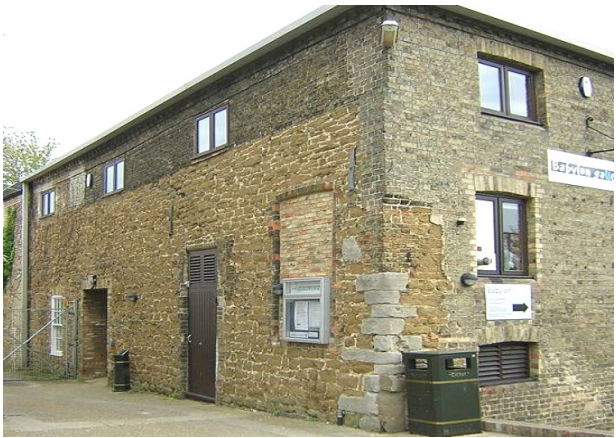
**VIEW OF WALL No 21**

< Galleting

Quoin Stones >

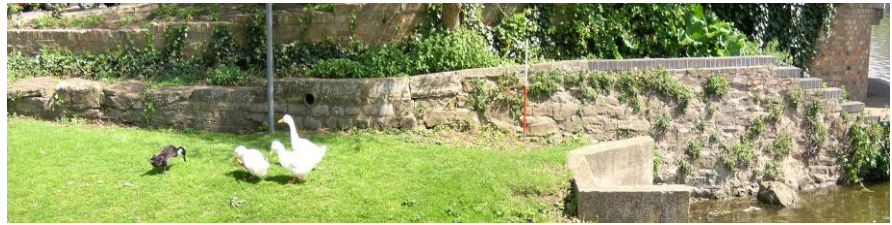
**PART OF WALL No 22**

**Dimensions in meters**  
 Length: 25  
 Height: 0 to 1.7  
 Thickness: 0.40 in places

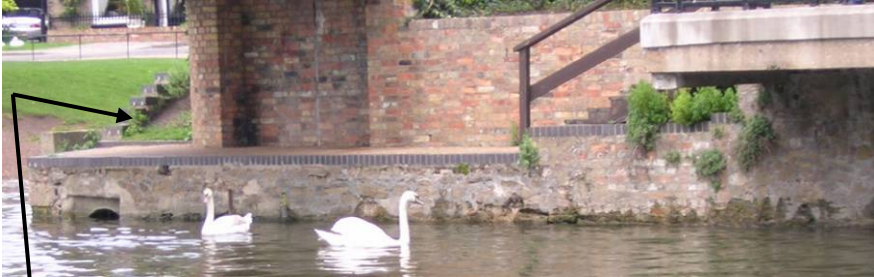
<b>VIEW OF WALL No 23</b>		
Wall 22

<b>SECTION II : WALL NUMBER 23</b>		<b>Date Surveyed</b> May 2006
<b>Location/General Description</b> Adjoins wall 22 and is situated under the bridge to the marina.		
<b>Construction</b> The stonework is random rubble, and part is in brickwork. There is a brick on edge coping of Staffordshire blue bricks.		
<b>Composition</b> 60 % Stone, mainly local sandstone 40 % brick	<b>Dimensions in meters</b>  Length: 12.25  Height: 0.7 to 1.5 above river level  Thickness: not known	
<b>Comments</b> Access to permit a detailed inspection of the wall would need to be accomplished by boat. This was not done. The wall was viewed from the opposite bank of the river.

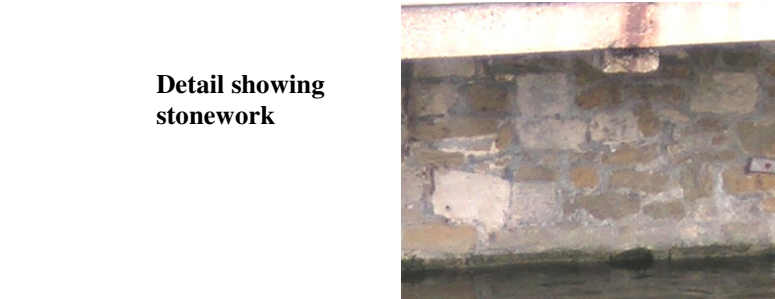
<b>VIEW OF PART OF WALL No 24</b>

<b>SECTION II : WALL NUMBER 24</b>		<b>Date Surveyed</b> May 2006
<b>Location/General Description</b> Lower south wall of part of the Babylon Gallery, under the public footpath. The part of the gallery is the west end with the lower roof line.		
<b>Construction</b> Random rubble stonework		
<b>Composition</b> 80% Local sandstone 20 % Barnack limestone	<b>Dimensions in meters</b>  Length: 13.95  Height: 1.5 above river level  Thickness: not known	
<b>Comments</b> Access to permit a close inspection of the wall would need to be accomplished by boat. This was not done. The wall was viewed from the opposite bank of the river.

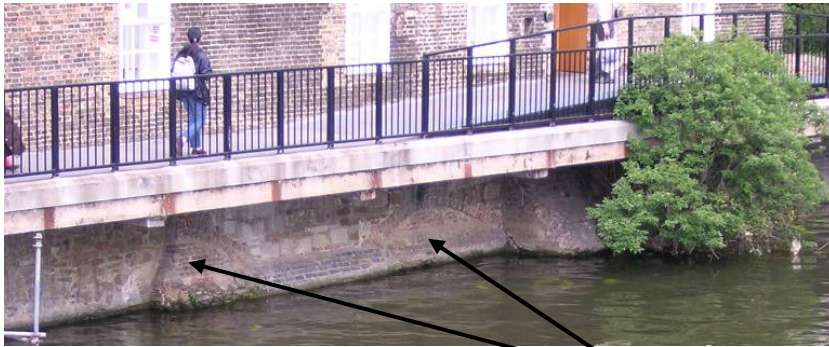
**VIEW OF WALL No 25**

Access to permit a close inspection of the wall would need to be accomplished by boat. This was not done. The wall was viewed from the opposite bank of the river.

**What appear  
to be old river  
accesses into  
the warehouse  
have been  
blocked up**

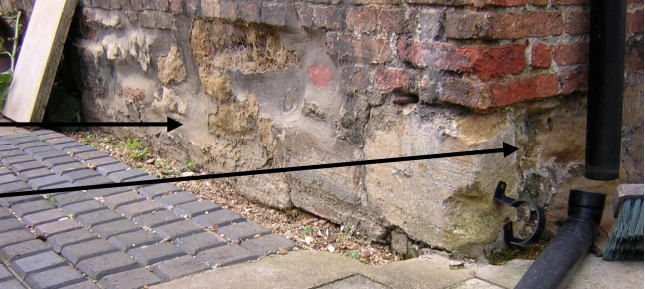
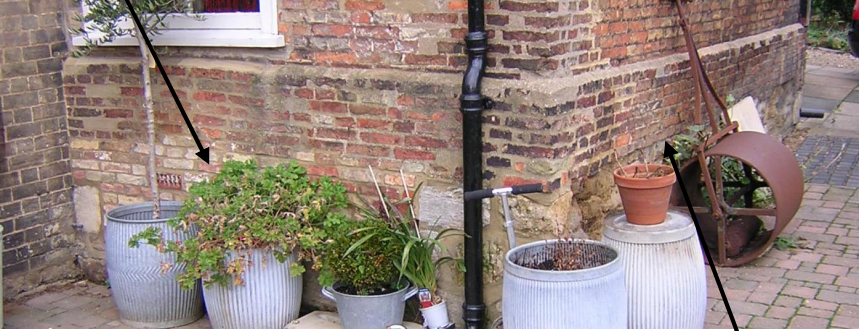
<p style="text-align: right;"><b>Section A</b></p> <p style="text-align: center;"><b>VIEW OF SECTIONS B AND A OF WALL 29</b></p>

<b>SECTION II : WALL NUMBER 29</b>		<b>Date Surveyed</b> January 2007
<b>Location/General Description</b> Vineyards House, The Vineyards. East end of the house at low level. Predominantly the gable end wall.		
<b>Construction</b> Random rubble stonework below a brick wall. The brick is pre 1725.		
<b>Composition</b> Sections A and C 80 % Local sandstone 10 % Uncertain stone due to a cementitious wash obscuring the details. Section B Mainly hidden by planters, but some Barnack rag is visible, as is pre 1725 brick.	<b>Dimensions in meters</b> Sections A B C Length: 5.45 2.80 0.60  Height: ** 0.75 0.32 ** A= 0.32 to 0.65 Thickness: not known	
<b>Comments</b>		
<p><b>Right Part of Section A and also Section C</b></p>

<p><b>Section B</b></p>

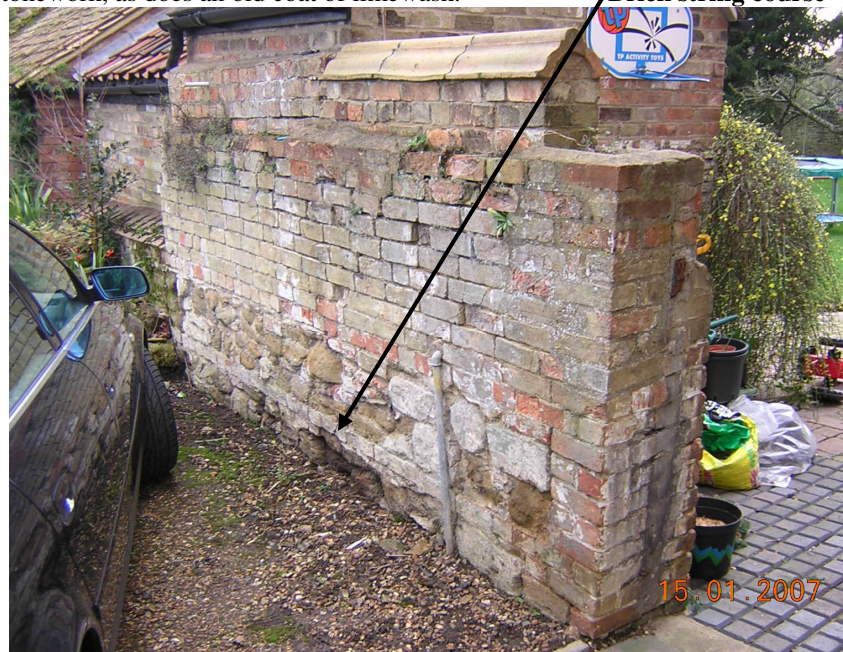
**VIEW OF PART OF THE NORTH FACE OF WALL 30**

**Comments**  
 A raised flower bed (hidden by the car in the photo below) obscures part of the stonework, as does an old coat of limewash.

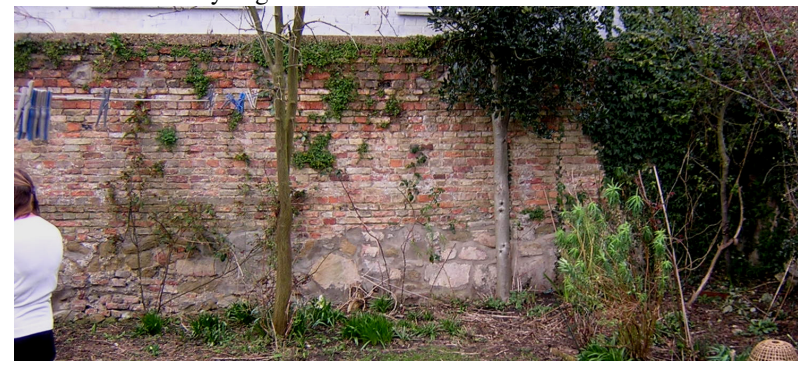
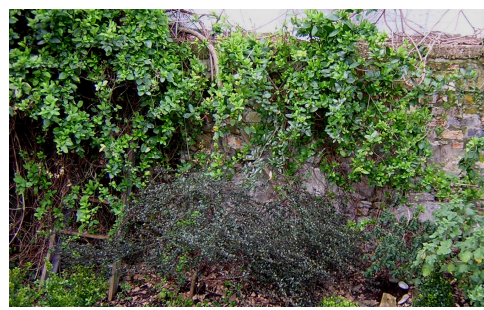
**Above**  
**PART OF SECTION B**

**Comments**  
 There is a length of brickwork between the house and section **A** and a 2.7 m length of brickwork between sections **A** & **B**. Section **A** is hidden by vegetation.

**Right:**  
**PART OF SECTION A**

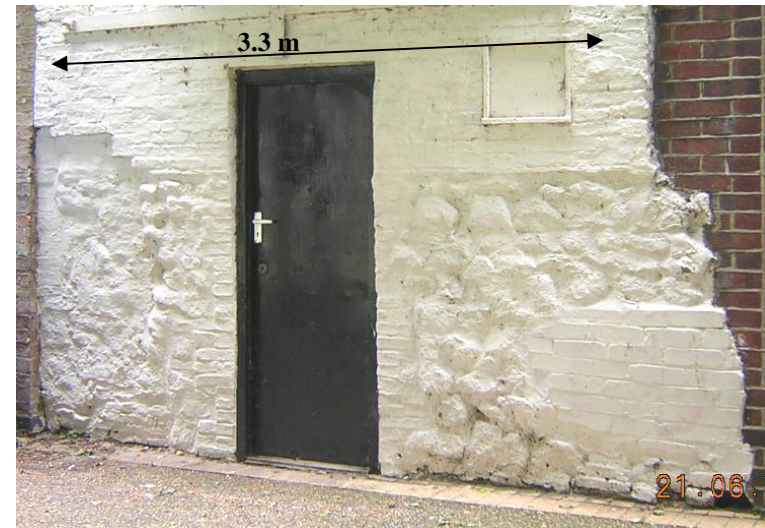
**VIEW OF WALL 02**

The wall has thick coats of paint obscuring the details.

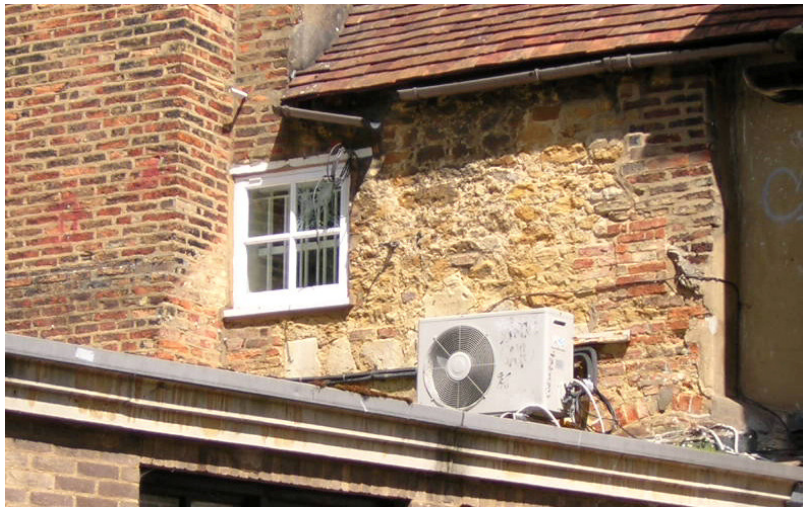
VIEW OF WALL 05

Access to the face of the wall was not obtained, and thus it was viewed at a distance and the dimensions assessed from a distance. The view was also obscured by other construction and equipment.

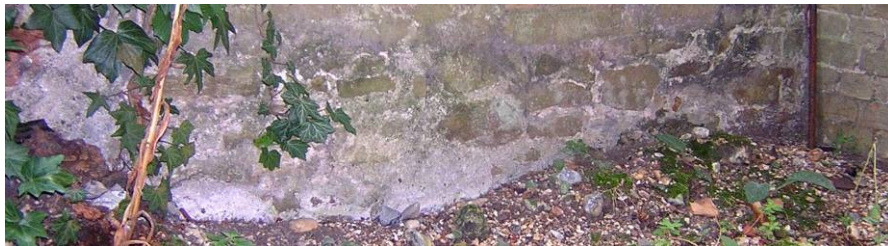
VIEW OF PART OF WALL 13

The wall is partially hidden by vegetation.

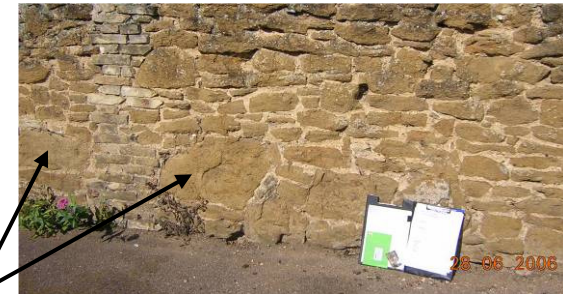
DETAIL OF INNER FACE OF WALL 14

Note that the inner face is accessed from Lynn Road, and the external face from the King's Arms car park, St Mary's Street.

Large Stones

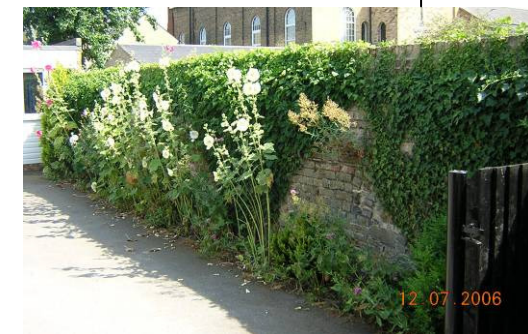
**VIEW OF PART OF SECTION B**

The inner face of the wall is hidden by vegetation for much of its length

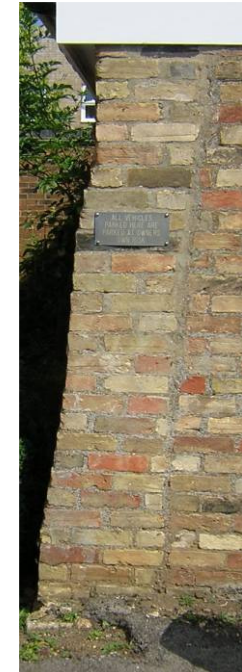
**END OF WALL 20**

Thickness: the brickwork end suggests 0.33 at the top and 0.45 at the base.

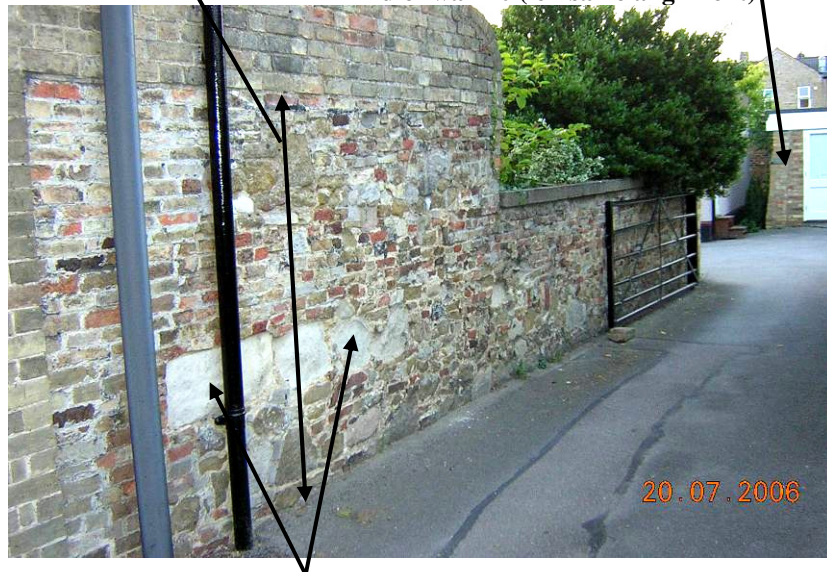
**VIEW OF WALL 21****SECTION III: WALL NUMBER 22**

Large sized stones of clunch

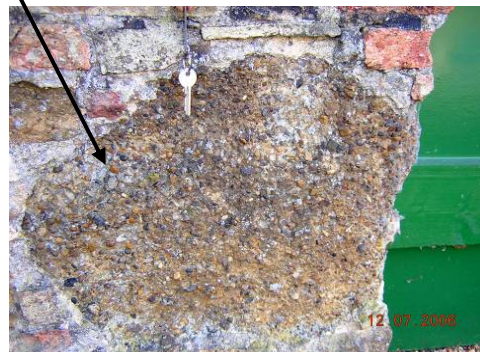
**SANDSTONE WITH GRIT INCLUSIONS**

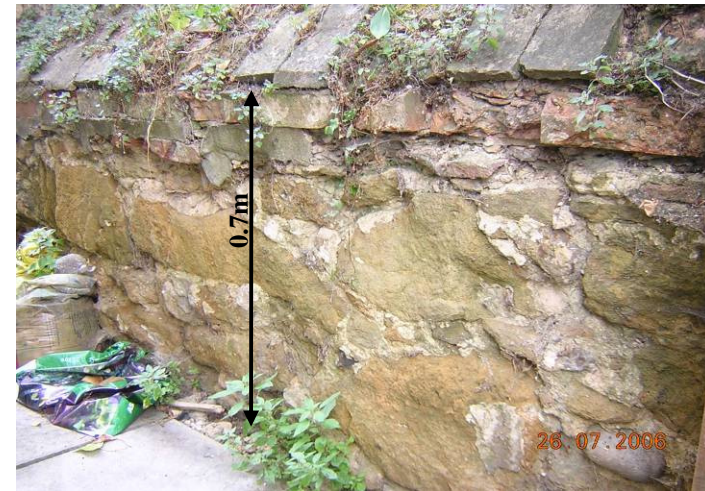
**PART OF WALL 26**

Thickness: Not known**Comments**Much of the wall is hidden behind stored goods.  
The inner face of the wall was surveyed.  
The occupant of No 33 reports that he proposes to modify the wall.

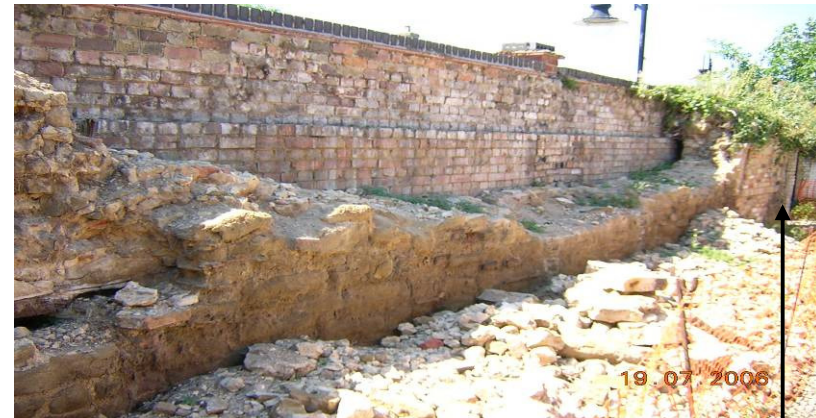
**VIEW OF SECTION A**

Section **A** has been partially demolished as it was unsafe. Section **C** is partially hidden behind vegetation. The end of this wall is visible, in section, from the neighbouring property.

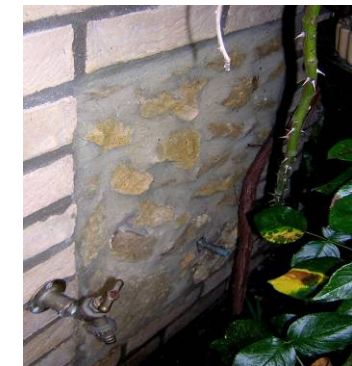
There is a small panel of stone within the brickwork of the extension.

**NEW STONE PANEL**

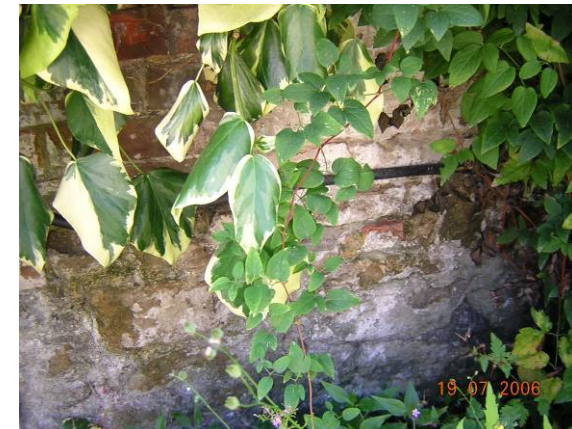
**VIEW OF PART OF WALL 32**

The inner face of the wall was surveyed. Most of the wall is hidden by vegetation.

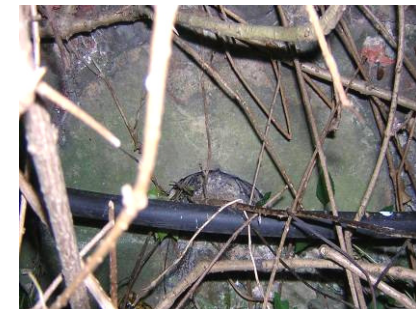
A view of 1 of 3 similar objects which may be parts of grind stones.

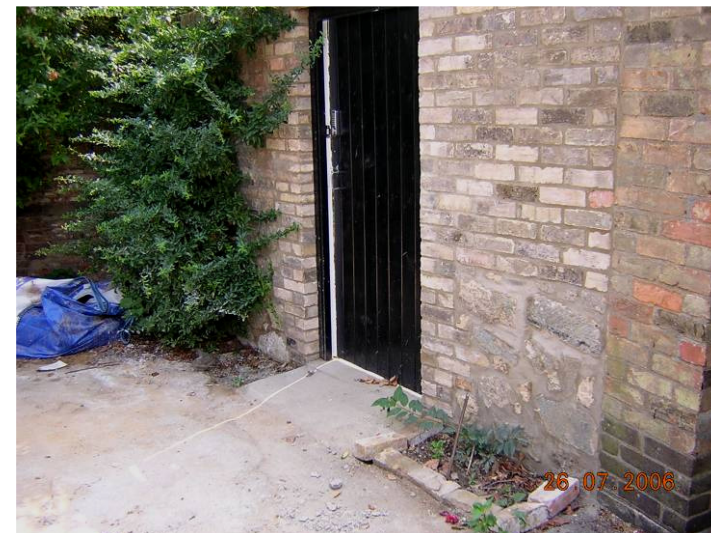
**VIEW OF WALL 36**

**Comments**The gate, reveals and panel between gate and garage have recently been constructed (the builders skip is still on site).  
Most of the wall is hidden by vegetation

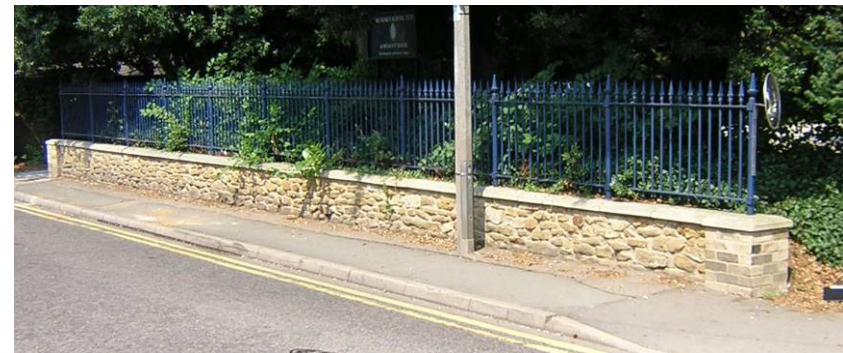
VIEW OF WALL 38

It is reported that in recent years the previous taller wall was demolished and the present one built on the same alignment, reutilising some of the original stones.

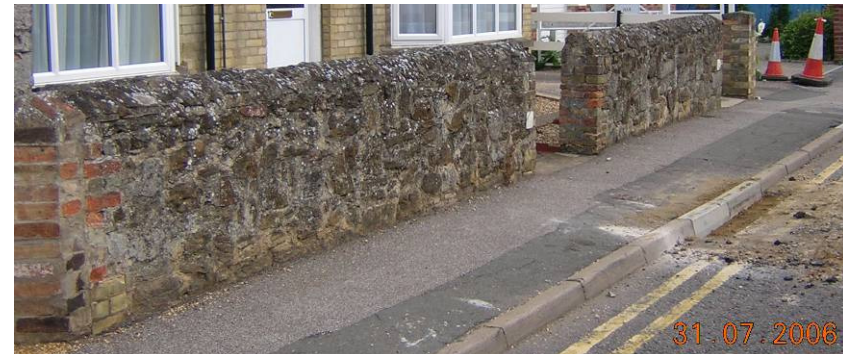
**VIEW OF WALL 40**

Heavy lichen growth is hiding some details of the stone.

Typical cross section of stone coping. A length of 0.95 m has also been finished with bricks inserted at the crown.

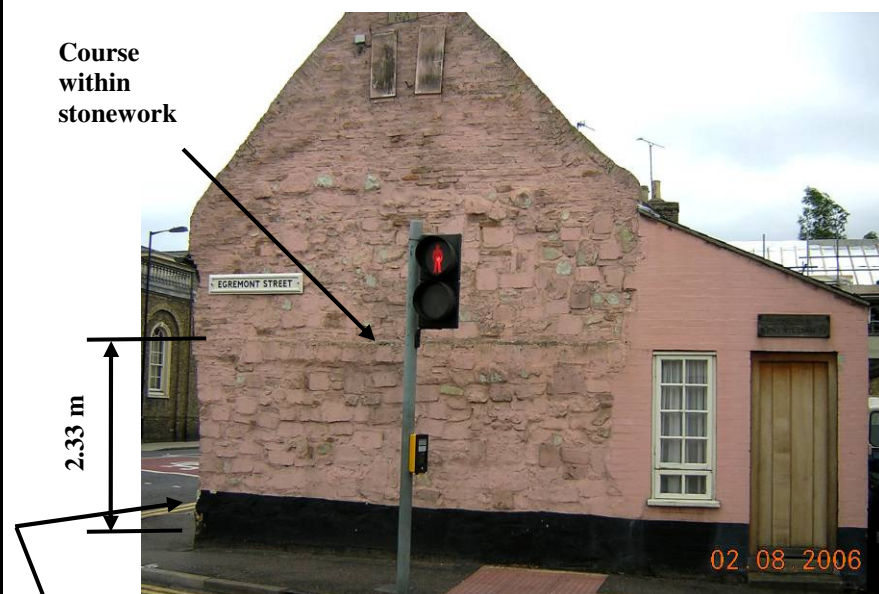
VIEW OF WALL 41

Approximately 1 % of the stone is visible through the paint (or limewash) and the bitumen coating at low level.

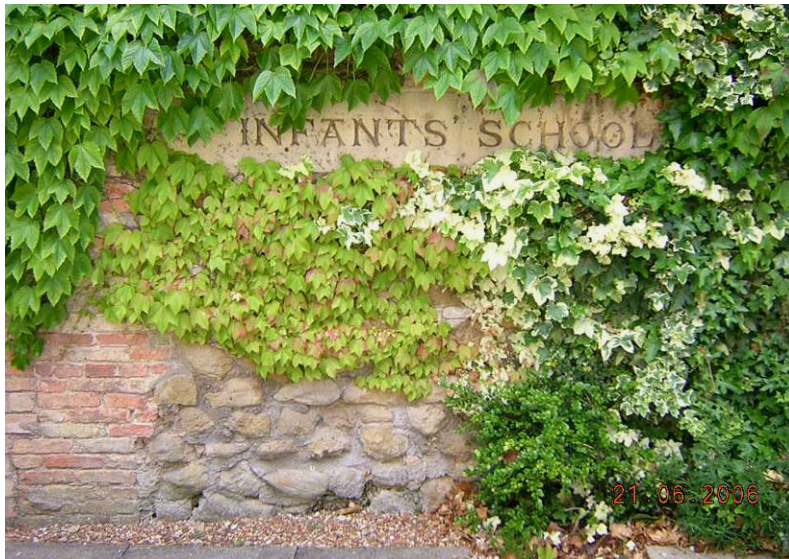
**VIEW OF PART OF WALL 43****SECTION III: WALL NUMBER 44**

Both sections of wall were mainly hidden by vegetation.  
 The inner face of the wall was surveyed.

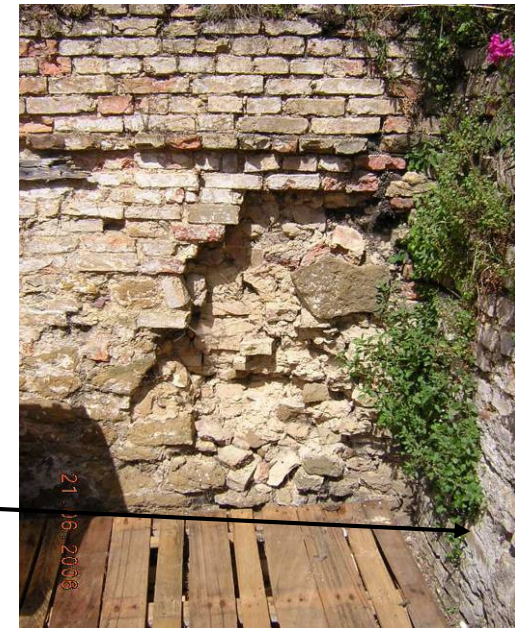
**VIEW OF PART OF WALL 44**

The inner face of the wall was surveyed.

A portion of the wall has collapsed exposing numerous bricks which are roughly laid.

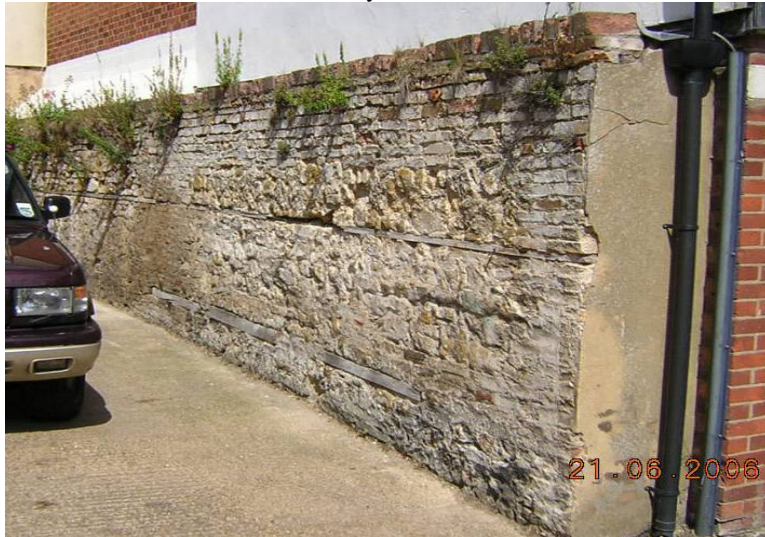
**VIEW OF WALL 45****SECTION III: WALL NUMBER 46**

The wall has had a coating of limewash, partially flaked off, but making a detailed examination difficult.

The inner face of the wall was surveyed.

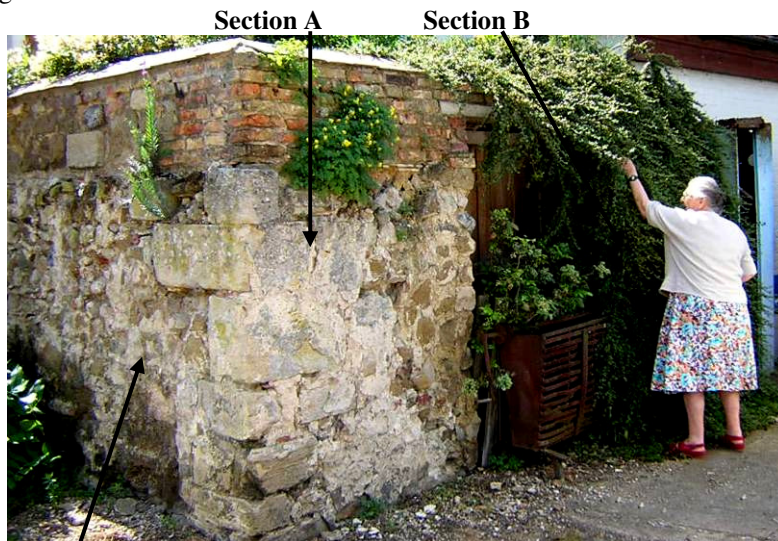
**VIEW OF WALL 47****SECTION III: WALL NUMBER 48**

The occupant reports that the top of the wall was modified in 1986. Section **A** has a 30 % coverage of rendering. Section **B** wall is hidden by vegetation.

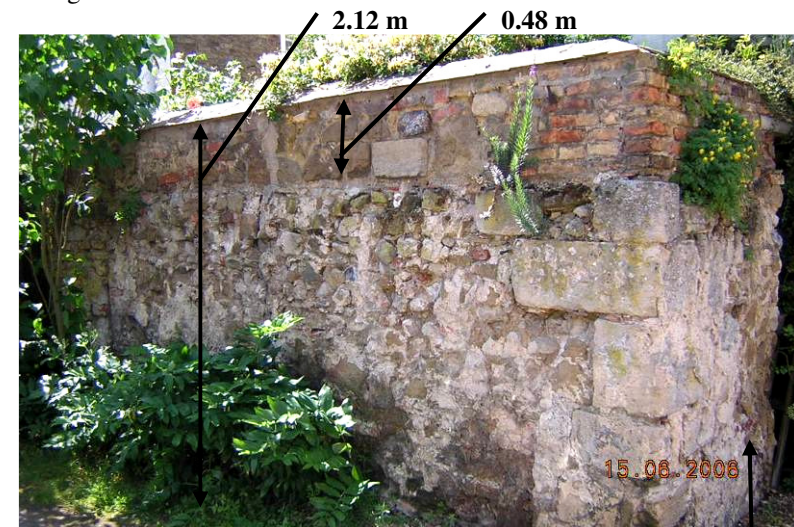
**VIEW OF WALL 48**

The occupant reports that the top of the wall was modified in 1986. Part of the wall is hidden by vegetation and approximately 30 % covered by rendering.

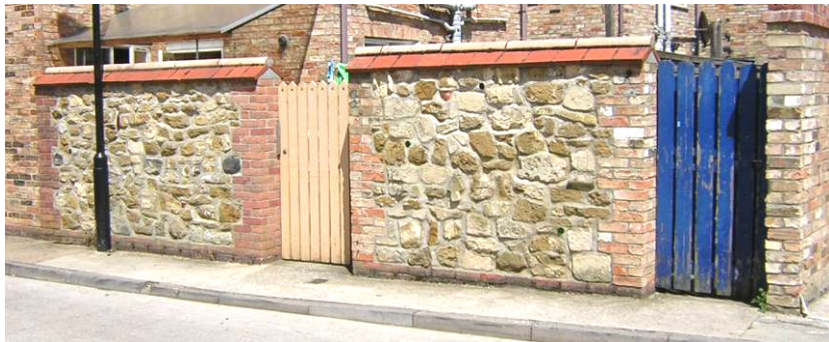
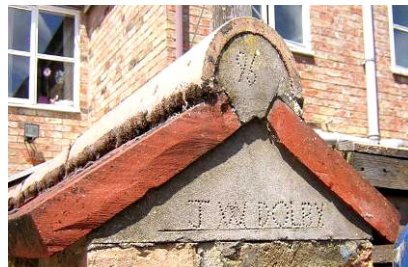
Above: VIEW OF WALL 51

**Right: DETAIL OF COPING**  
 Also showing '96 and name of JW Dolby (there are other initials on the wall)

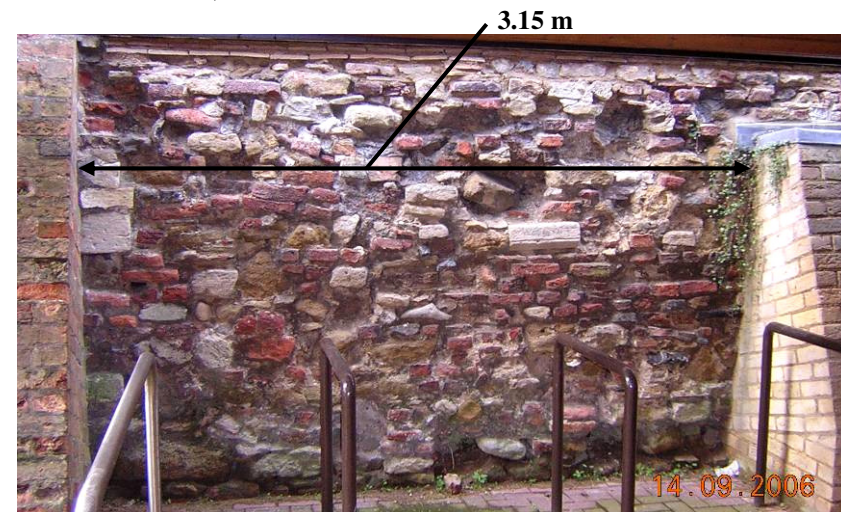
VIEW OF SECTION A

The wall has deteriorated on the inner face with some facing stones having fallen away. On the external face the top meter of the wall has been crudely patched with cement mortar, bricks and tiles
