Ely & District Archaeological Society

# A SURVEY OF STONE WALLS IN ELY

Sections I -V Complete

# **SURVEY OF WALLS IN ELY**

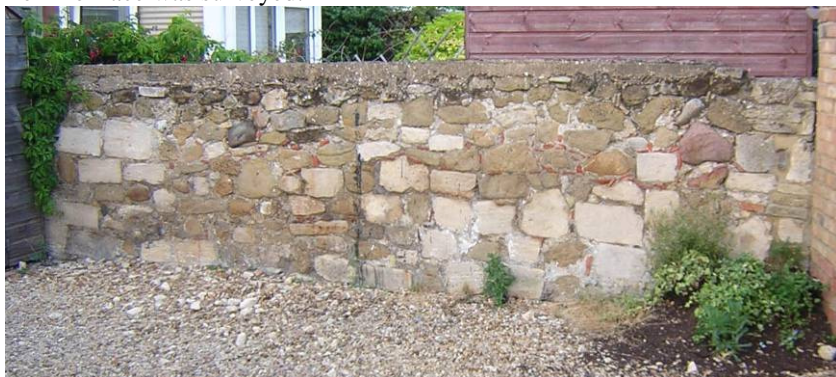
Above:  
**VIEW OF PART OF WALL 53**

A stone has the date 1749 carved on it.  
 Some of the wall is hidden by a timber shed.  
 The inner face was surveyed.

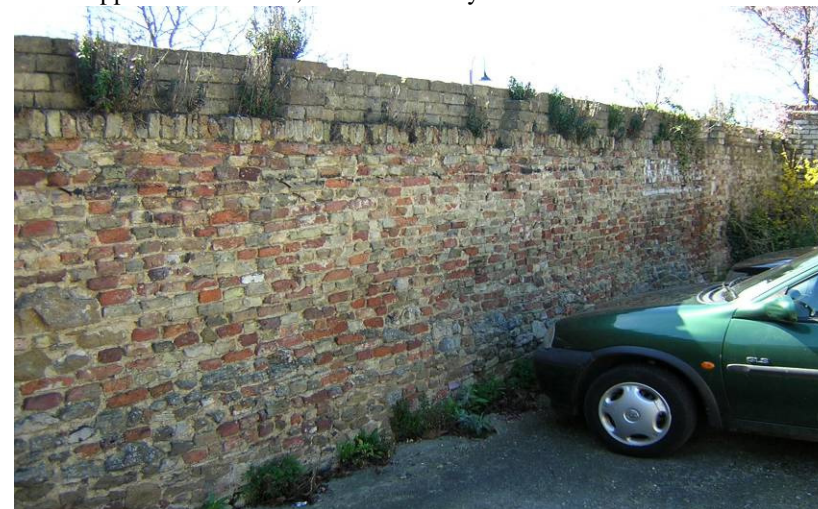
**VIEW OF PART OF WALL 54**

The inner face of the wall was surveyed.  
 The external face (towards Waitrose) has been faced with modern brickwork.  
 The wall appears to continue, but is hidden by the house.

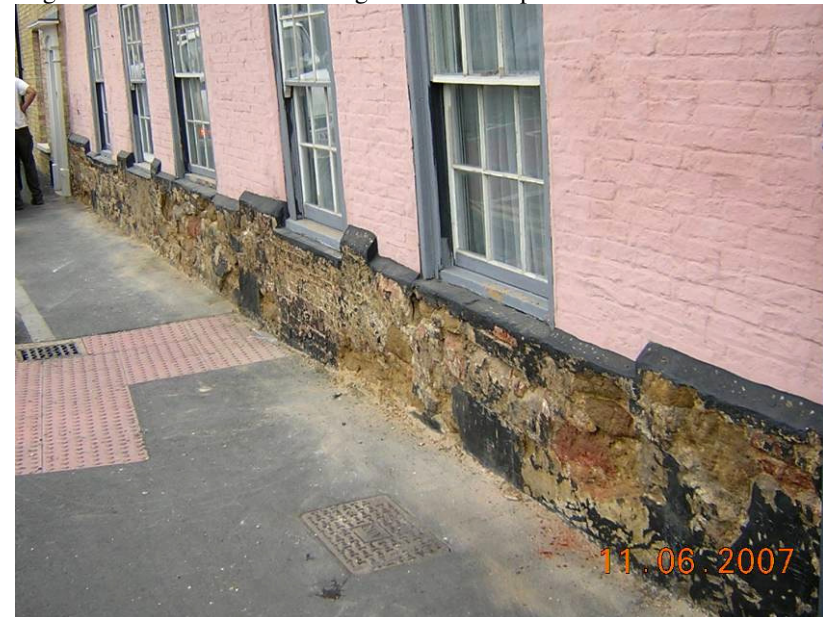
**WALL 58**

**Composition**50% local sandstone  
20% brickwork  
10% pink loosely bound igneous rock  
20% not clearly visible**Dimensions in meters**Length: 13.9

Note that this wall is part of the same building as wall 41, but was not distinguishable as stonework during the earlier inspection.

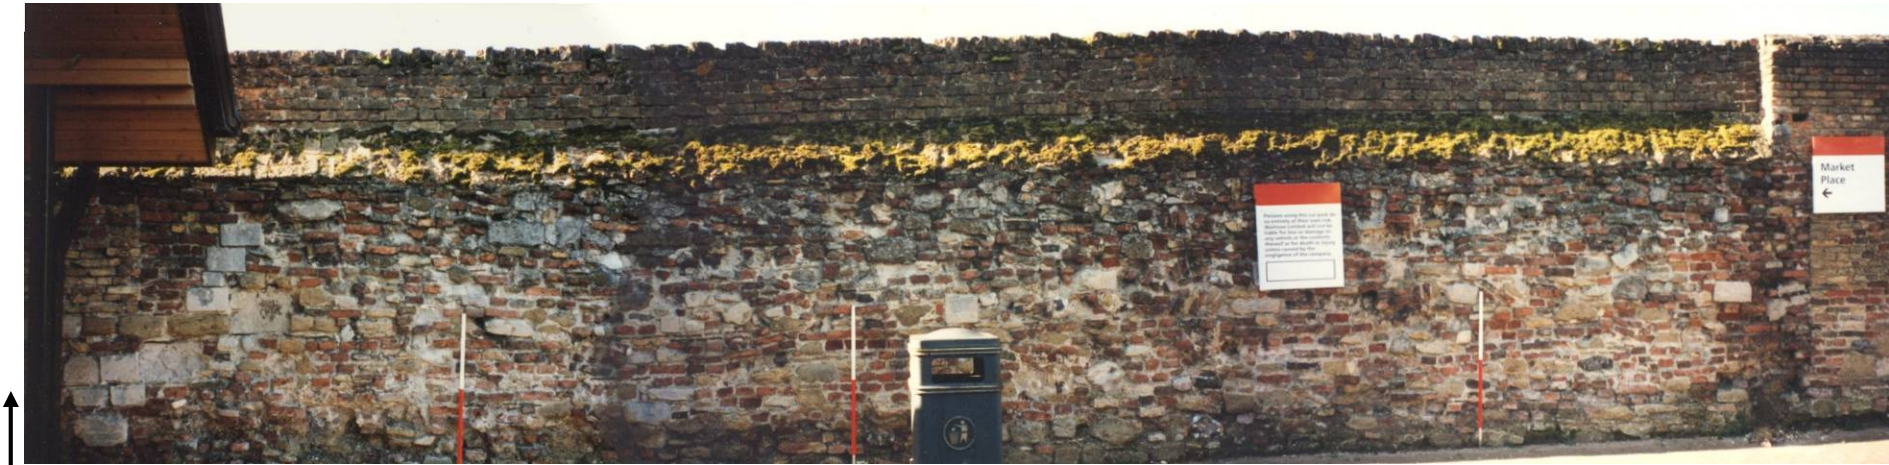
**VIEW OF PART OF WALL S1**

The length of wall at this end remains in existence see Wall No 52

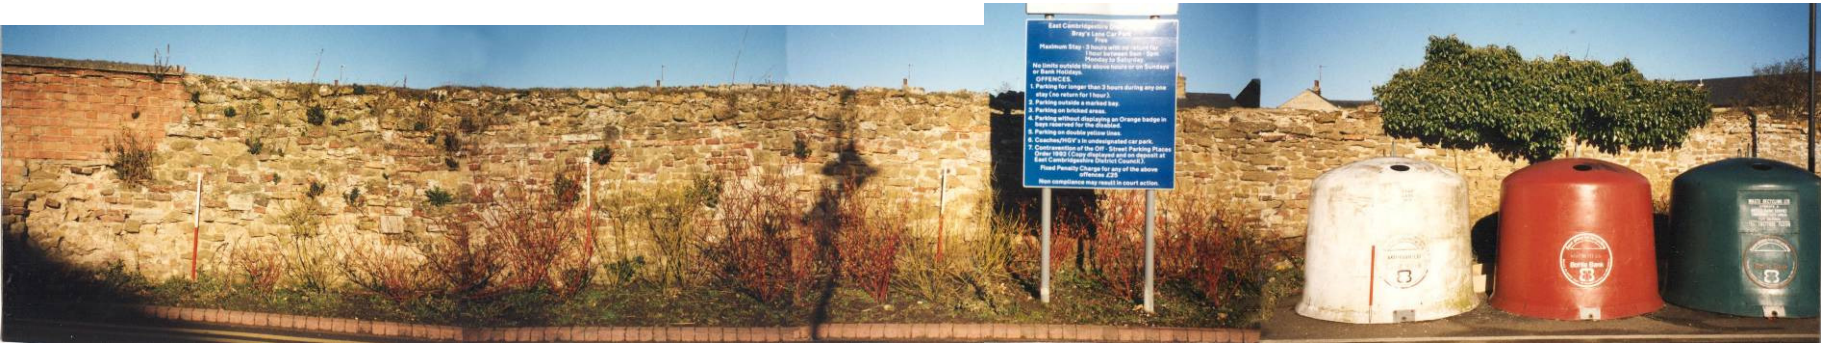
VIEW OF PART OF WALL S7

<b>SECTION III : WALL NUMBER S7</b>		<b>Date Surveyed</b> November 1997
<b>Location/General Description</b> Western wall of Waitrose car park		
<b>Construction</b> Roughly coursed with small boulders of sandstone. South end much worn and broken for around 2 metres. Slightly larger sandstone blocks on upper half. Wall changes to almost all brick at northern end.		
<b>Composition</b> Sandstone Brick (assorted colour and size, different sizes but mostly small) Tiles Barnack Ragstone, some ashlar cut. Included several column end between 0.12 m and 0.15 m in diameter) Oolitic limestone Flints, including 1 large nodule and smaller nodular and tabular stones Field stones (quartzite?) 2 nodules Kimmeridge clay	<b>Dimensions</b>  Length: 40.6 m  Height: approx 1.95 m, varies from stone to stone.  Thickness: not known	
<b>Comments</b> Rather curvaceous line! Considerable growth of wall plants (eg snapdragon, sedum). Planted shrubs along east side obscures much of wall  <u>Reverse of wall</u> (western side) is heavily painted and rendered, rendering about 2 cm thick. No stone is therefore visible except for 3 pieces of sandstone where the rendering has been knocked off.

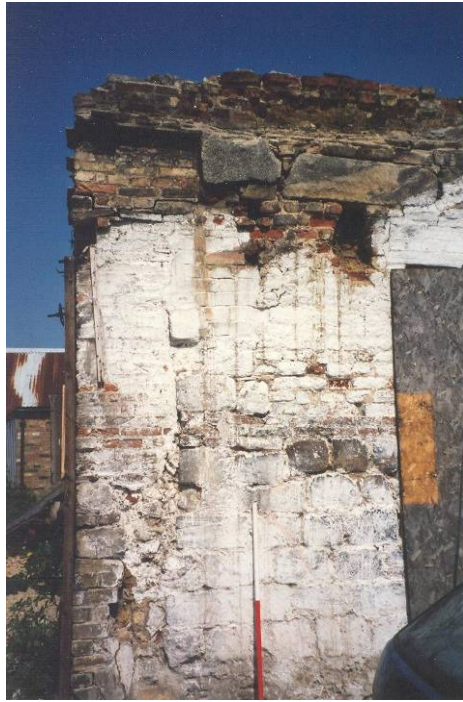
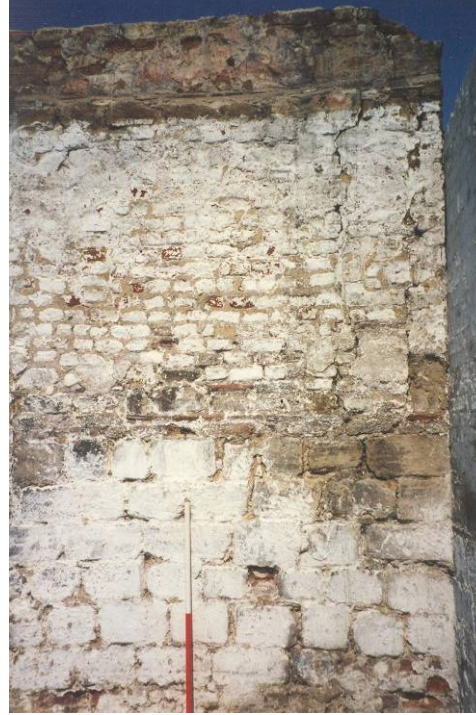
**TWO PARTS OF WALL S8**

<b>SECTION III : WALL NUMBER S8</b>		<b>Date Surveyed</b> November 1997
<b>Location/General Description</b> South gable end of old barn.		
<b>Construction</b> Coursed. Base of 2 courses brick and stone, then 6 courses ashlar. Then a layer of brick/tiles/stones, then brick layer. Topped by sandstone remains of previous gable.) Stone quoin on LHS with brick above.		
<b>Composition</b> Limewashed Barnack Ragstone, ashlar cut 15x18 cm Few bits of tile in mortar. Clunch (one piece) in quoin	<b>Dimensions</b>  Length: 5.22 m (includes 0.55 m brick extension on LHS).  Height: 1.45 m to top ashlar, 1.85 m to top of brick/tile/stone layer.  Thickness: 0.66 m	
<b>Comments</b>

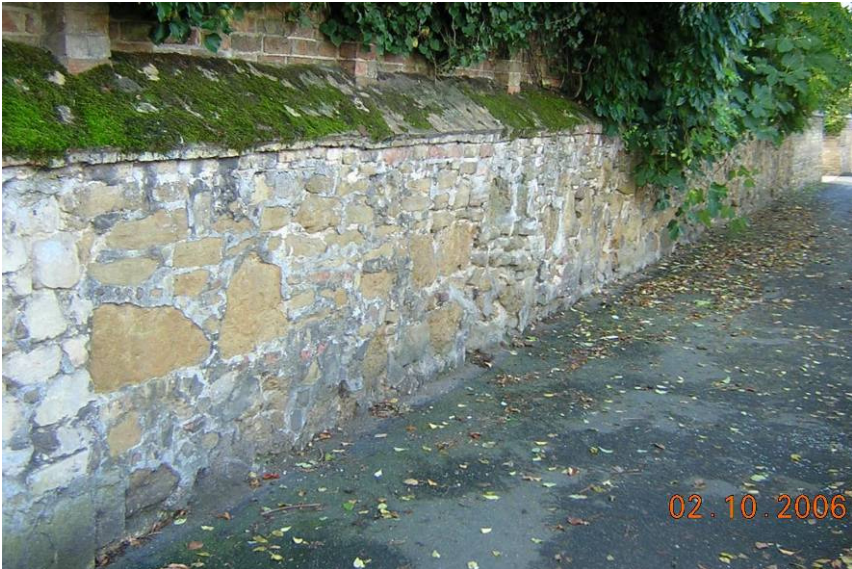
<b>VIEW OF WALL 1B</b>

<b>SECTION IV : WALL NUMBER 1B</b>		<b>Date Surveyed</b> February 2000
<b>Location/General Description</b> West end of garden wall of 3 West Fen Road		
<b>Construction</b> Random rubble construction, including numerous large pieces of sandstone. Insertions of brick and smaller stones.		
<b>Composition</b> Predominantly sandstone. Sandstone is of varied composition with a fair bit of grit inclusion. There are 14 large stones. 9 flints including one 15cmx15cm tabular or knapped flint. 5 field stones – quartzite.	<b>Dimensions</b> Length: 19.75 m Height: 2.71 m (1.36 - 1.4 m stone) Thickness: 0.5 m (estimate) at base	
<b>Comments</b> Examples of size of large sandstone blocks – 30cm x 95cm, 50cm x 40cm

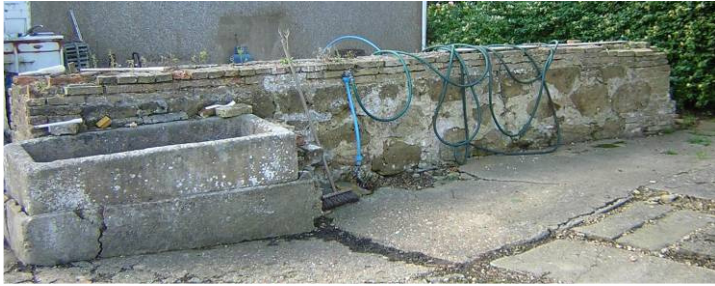
<b>VIEW OF WALL 4</b>

<b>SECTION IV : WALL NUMBER 4</b>		<b>Date Surveyed</b> February 2000
<b>Location/General Description</b> Back yard of 40 West Fen Road. 5.1metres north of house dated 1819. Part of farm building of Green's Farm – believed to have been there over a century.		
<b>Construction</b> Rubble construction with brick pier end. Now topped with courses of yellow brick – would have been much higher when in use.		
<b>Composition</b> Almost all sandstone –3 large stones. A few with grit inclusions. Very thick mortar. Some traces of plastering. The brick end pier and 3 courses of brickwork over the stone are pre 1725 bricks	<b>Dimensions</b> Length: 5.6 m  Height: 0.75 m of stone  Thickness: 0.45 m	
<b>Comments</b> Brick wall along street to the North has stone footings. Said to have been south wall of cowsheds. Left over from farm – a trough for cattle made from a single block of limestone mounted on concrete. Trough dimensions 1.05 x .0.7 x 0.55, with 90 mm thickness round rim and an internal depth of 0.33m. In October 2009 the resident explained that the wall was the remnant of the end wall if a granary and pantries which were removed about 50 years ago.

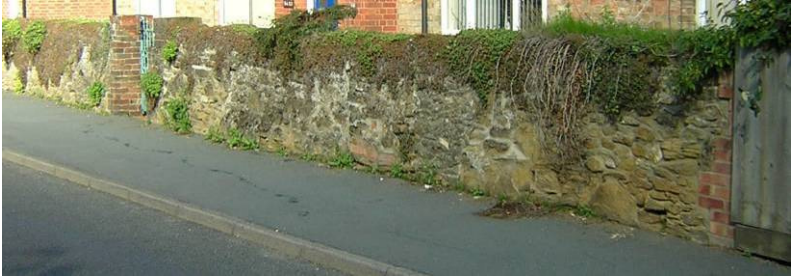
<b>VIEW OF WALL 5</b>

<b>SECTION IV : WALL NUMBER 5</b>		<b>Date Surveyed</b> February 2000
<b>Location/General Description</b> Street wall along flats at 48-54 West Fen Road 'The Pantiles'		
<b>Construction</b> Brick ends to each section for gates, etc. Stone construction both side; small buttresses of red brick on inner side. Top has course of near vertical stones		
<b>Composition</b> 95% sandstone – much lichen cover. Variable but flattish slabs. Stones on the small side. 2 pieces tile and some brick. Recently repaired and modern red brick pier to East end. Section 2 has roughly repointed section in middle with some brick inserted at random.	<b>Dimensions</b> Length: 8.8 m & 8.9 m (W to E)  Height: 1.2 m  Thickness: 500 mm at top Widens at base	
<b>Comments</b> Not in good condition. Inner side closely planted with mature shrubs that conceal face. Outer side roughly repaired with thick mortar in places. Top has strong growth of stonecrop and other wall plants. The 2 sections are virtually identical, the western one being more backed by brick on the inside. Approximate buttress dimensions:- 600 mm wide, 1 m high, projects 120 mm from wall at base. Brick chamfered to wall at top. 28 Sep 2005 – A resident reported that the stone wall formerly extended further East, to the corner of Trinity Close.

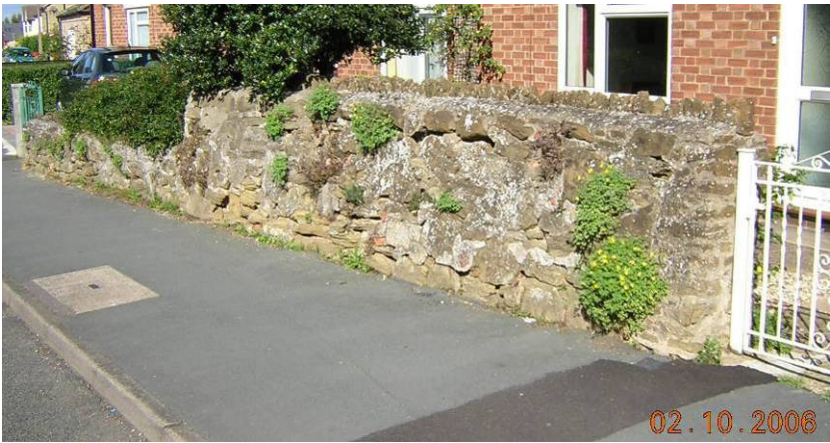
<b>VIEW OF WALL 6A</b>

<b>SECTION IV : WALL NUMBER 6</b>		<b>Date Surveyed</b> February 2000
<b>Location/General Description</b> North side of West Fen Road, in front of numbers 56 and 58.		
<b>Construction</b>		
<b>Composition</b> 90% sandstone A few flints Mortar between stones fairly thick, but section 6A semi-plastered on outside of road – perhaps rough repair of dilapidation?	<b>Dimensions</b>  Length: 9.5 m  Height: See 6A and 6B  Thickness: See 6A and 6B	
<b>Comments</b> Probably originally a continuation of wall 5. Wall drops in height from No 54 to No 56, and has been modified more recently than wall 5, or else gardens kept clearer.

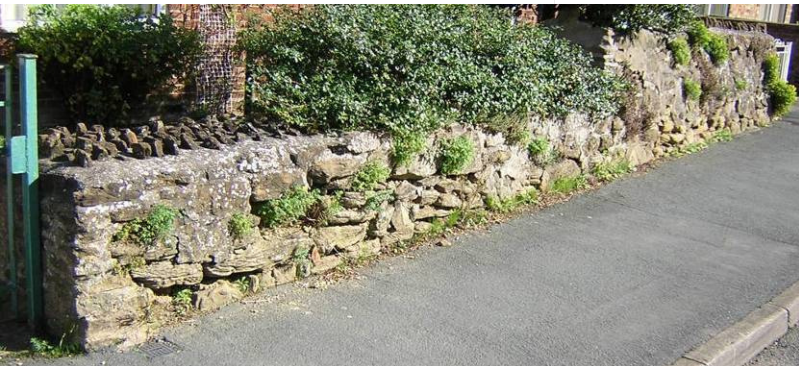
<b>VIEW OF WALL 6B</b>

<b>SECTION IV : WALL NUMBER 6B</b>		<b>Date Surveyed</b> February 2000	
<b>Location/General Description</b> In front of 58 West Fen Road			
<b>Construction</b> Random rubble stonework.			
<b>Composition</b> See 6. Brick-faced on inner side.		<b>Dimensions</b>  Length: 4.3 m  Height: 0.55 m  Thickness: 0.6 m	
<b>Comments</b> Top of wall mortared with random scatter of upright small sandstone pieces.			
External face >

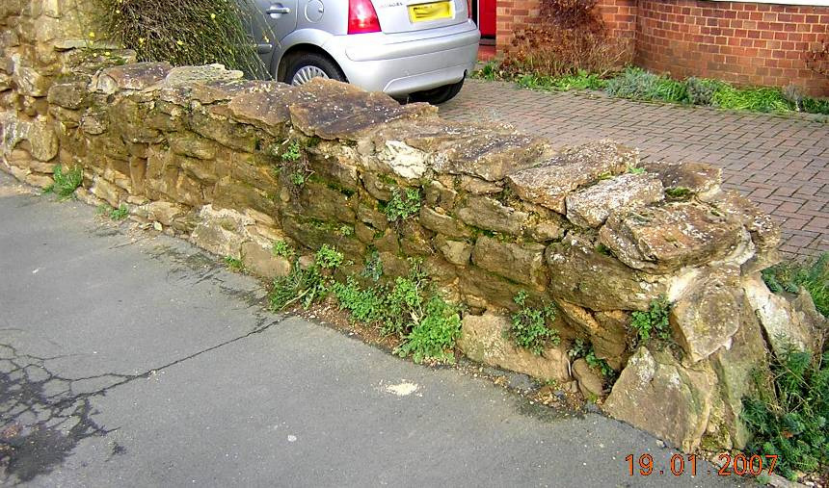
<b>VIEW OF WALL 7A</b>

<b>SECTION IV : WALL NUMBER 7A</b>		<b>Date Surveyed</b> April 2003
<b>Location/General Description</b> Eastern end of wall 7		
<b>Construction</b> See 7.		
<b>Composition</b> Almost all sandstone A few bricks (patching)	<b>Dimensions</b>  Length: 5.6 m  Height: 0.65 m  Thickness: 0.35 m at top 0.6 m at base	
<b>Comments</b> Update in April 2003 – wall now topped by slabs of sandstone mortared flat – size 450 x220 mm approx.

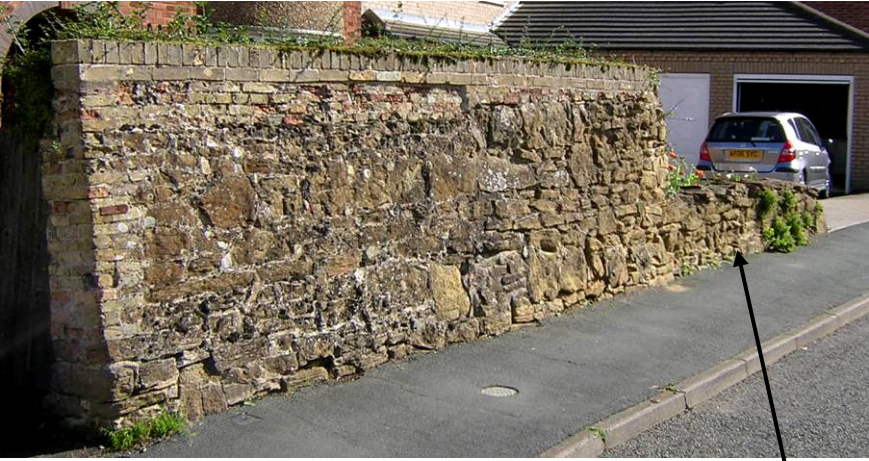
<b>VIEW OF WALL 7B</b>

<b>SECTION IV : WALL NUMBER 7B</b>		<b>Date Surveyed</b> April 2003
<b>Location/General Description</b> Western end of wall 7		
<b>Construction</b> See 7.		
<b>Composition</b> 95 % sandstone, including 7 large stones. A few bricks (patching) Topped with brick 2-4 courses of pre 1725 bricks and then 1 horizontal and one brick on edge course of newer brick. Some tiles to level up. One end of the wall is finished with pre 1725 bricks.	<b>Dimensions</b>  Length: 3.7 m  Height: at E end 1.8 m, of which 0.40 m brick: at W end 1.95 m, of which 0.45 m brick  Thickness: 0.35 m at top 0.6 m at base	
<b>Comments</b>

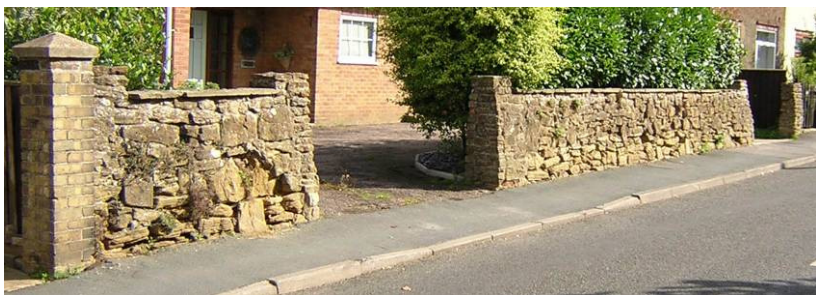
**VIEW OF WALL 8**

**Comments**  
 Wall at least partly reconstructed, presumably when present house built. Capped with horizontal Yorkstone slabs about 40 mm thick. Show flecks of mica reflecting light. Structurally in better condition than many of neighbours. Cross-section similar to walls 5 to 7.

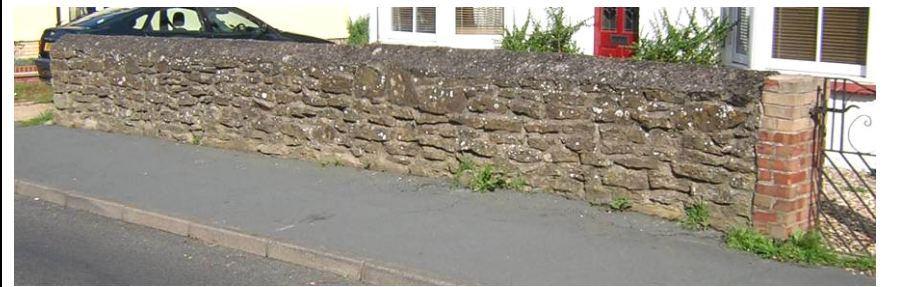
**VIEW OF MAIN LENGTH OF WALL 9**

**Construction**  
 Well coursed. Both faces of wall vertical. Pointing fairly consistent and in sound condition.

**Comments**  
 Wall appears to be rebuilt on a line set back from original (re-alignment).

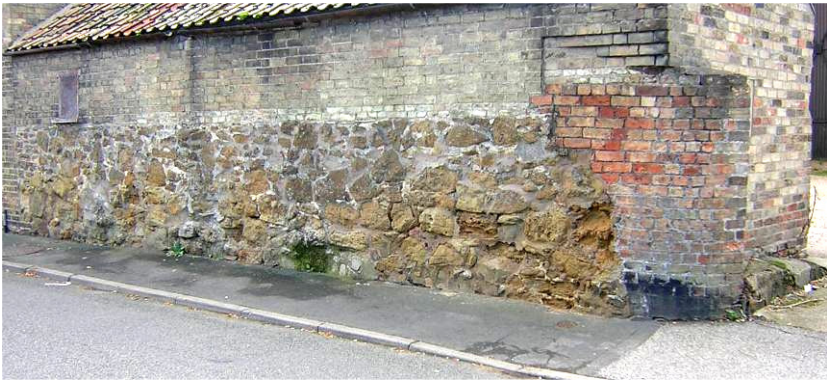
<b>VIEW OF WALL 10</b>

<b>SECTION IV : WALL NUMBER 10</b>		<b>Date Surveyed</b> February 2000
<b>Location/General Description</b> 19 West Fen Road Red Cross Hall, south of Chiefs Street Stone wall to west of 'cottage'.		
<b>Construction</b> Lower part stones. Upper part: 2 courses pre 1725 brick topped with 10 courses of standard sized bricks.		
<b>Composition</b> 90% sandstone, half of which contained grit inclusions. 3 large stones. Smaller pieces of sandstone at top A few old bricks Pantile fragments 2 flints Pieces of stone slab in more recent piecemeal mortar replacement.	<b>Dimensions</b>  Length: 8.6 m  Height: Total 2.37 Stone base 1.4 m  Thickness: 0.28 m – 0.3 m at top	
<b>Comments</b> Much mortar repair work. Wall was once colour-washed as were adjacent 19 <sup>th</sup> century walls to make "shed", rear being closed in by boarding and door in 2003.

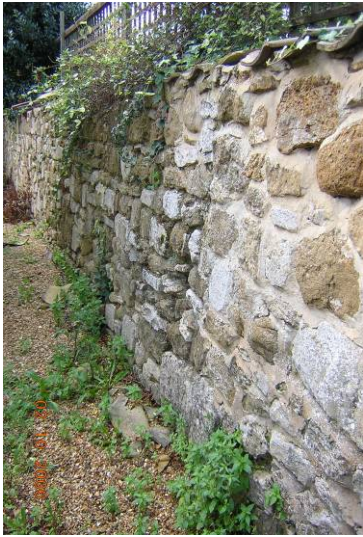
<b>PART OF WALL 11</b>

<b>SECTION IV : WALL NUMBER 11</b>		<b>Date Surveyed</b> February 2000 <b>(Resurveyed October 2006)</b>
<b>Location/General Description</b> Rear wall to gardens of 2 to 11 Bakers Corner.		
<b>Construction</b> Very roughly coursed but irregularity of blocks gives a very higgledy-piggledy appearance. The section in the centre/north has been partially re-mortared. The coping for approximately 40% of the wall is formed with pantile roof tiles.		
<b>Composition</b> 80% Mixed sandstone including gravelled type. 20% Barnack ragstone and limestone – probably ex cathedral or St John's Hospital. Many Barnack pieces show ashlar features. There are a variety of shaped and worked stones including a small column drum. Pantile covering	<b>Dimensions</b>  Length: about 33.6 m  Height: 1.46 m to base of Pantiles Thickness: 0.3 m	
<b>Comment</b> This is likely to represent an old boundary wall.

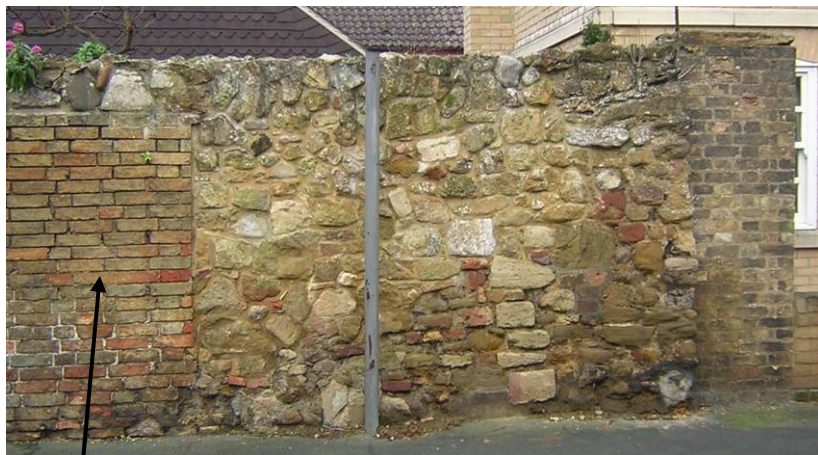
**VIEW OF WALL 12A**

<b>Composition</b>	<b>Dimensions</b>
Mostly sandstone About 10% Barnack ragstone, some ashlar cut Fields stones (unusually high number) Brick Flints 2 Kimmeridge clay nodules	Length: 2.86 m  Height: 2.03 m at south 2.11 m at north  Thickness: approx 0.35 m

**Comments**  
 Wall juts out into road by a further 0.18 m for about ½ metre at north end.

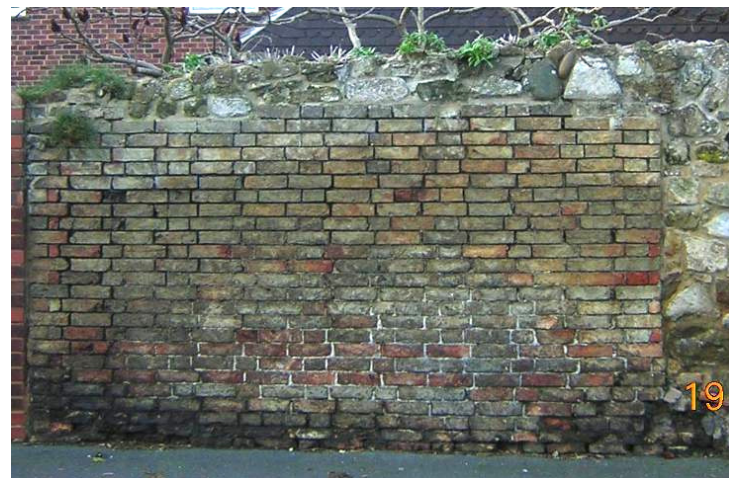
**VIEW OF WALL 12B**

<b>Composition</b>	<b>Dimensions</b>
Bricks – pre 1725 size.  Stone capping: Sandstone Barnack ragstone Fields stones Flint	Length: 3.3 m  Height: 1.76 m brick + 0.26 m stone  Thickness: n/k

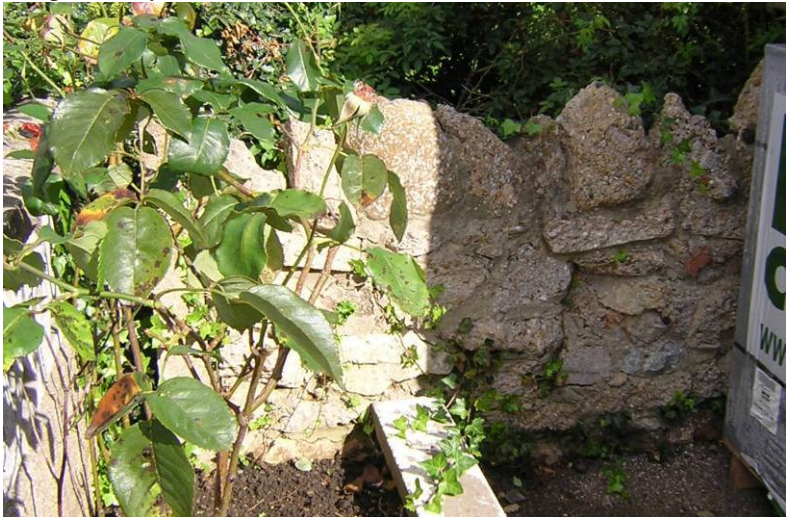
<b>PART OF WALL 13A</b>

<b>SECTION IV : WALL NUMBER 13A</b>		<b>Date Surveyed</b> February 2000
<b>Location/General Description</b> North-side wall of front garden of 45 Chiefs Street.		
<b>Construction</b> Roughly coursed with very irregular-sized capping		
<b>Composition</b> Mostly old concrete Sandstone Field stones Brick Tile	<b>Dimensions</b>  Length: 8.2 m  Height: 0.87 m – 0.95 m  Thickness: 0.10 m – 0.12 m	
<b>Comments</b> Probably made from an area of concrete, possibly an old patio or driveway, broken up and recycled.

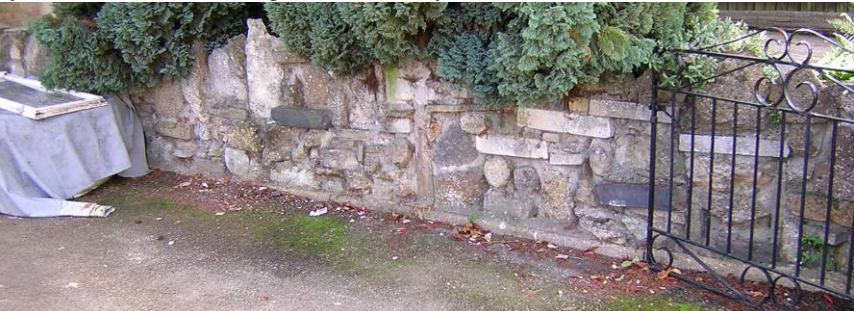
<b>PART OF WALL 13B</b>

<b>SECTION IV : WALL NUMBER 13B</b>		<b>Date Surveyed</b> February 2000
<b>Location/General Description</b> South-side wall of front garden of 45 Chiefs Street.		
<b>Construction</b> Non-coursed of blocks of very variable size and shape. Capping also very irregular-sized.		
<b>Composition</b> Old concrete Sandstone (one piece looks like former windowsill) Clunch (large pieces) Barnack ragstone (column sections) 3 long thin blocks marble 1 long thin block oolite Field stones – including midland quartzite and a fine volcanic stone including mica 3 recycled concrete boundary-style fence posts 3 oblong manufactured black stones 1 grey granite cube	<b>Dimensions</b>  Length: 7.8 m  Height: 0.80 m – 0.98 m  Thickness: 0.10 m – 0.12 m	
<b>Comments</b> Much more variable in composition than 13A. Appears to be built to echo the style of 13A and wide range of stones may also be deliberate.

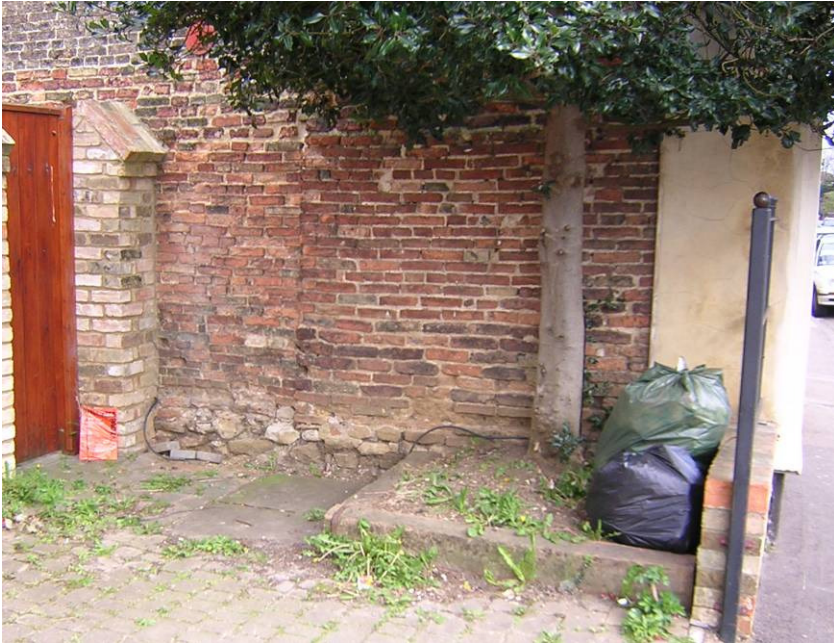
Wall showing stonework at base and pre 1725 brickwork above.

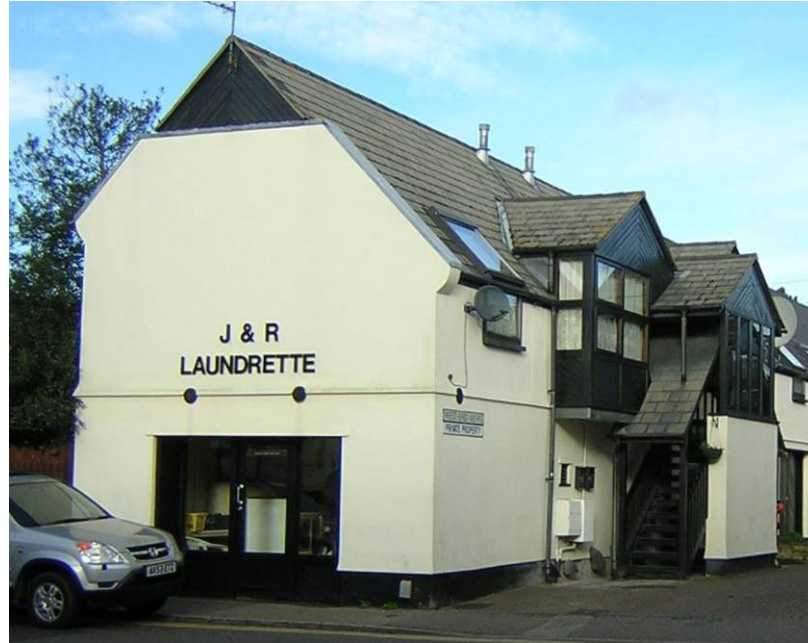
General view of building after the render was applied.

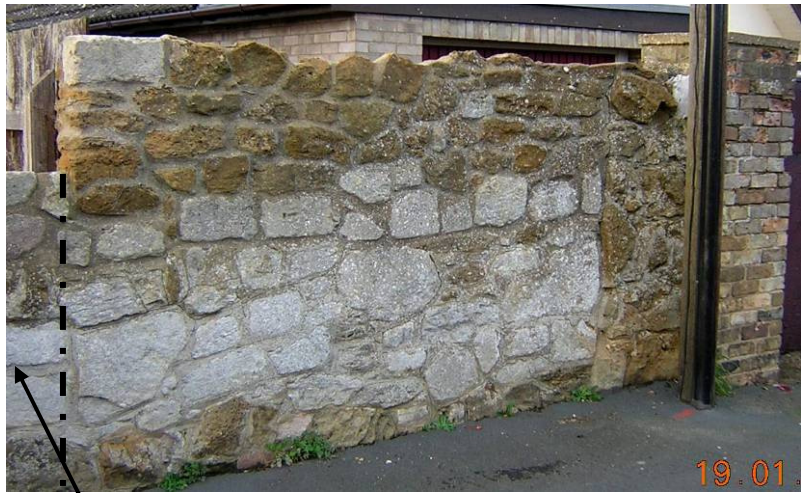
Wall 15

<b>SECTION IV : WALL NUMBER 15</b>		<b>Date Surveyed</b> April 2003
<b>Location/General Description</b> Front wall of 9A Little Lane, on west side of Little Lane.		
<b>Construction</b> Crudely coursed. Upper and lower portions of different composition - lower mostly medium-sized lumps of local sandstone and upper mostly of Barnack ragstone. Pointed with thinnish mortar, with trowel point drawn round stones. Very thin for height.		
<b>Composition</b> Local sandstone Barnack ragstone – some pinkish / fire-damaged 1 flint in base layers	<b>Dimensions</b> Length: 7.0 m Height: 1.13 m Thickness: 0.15 m	
<b>Diagram showing numbering of properties and walls in Little Lane</b>		
<p><b>Stone walls located:</b>  <b>circles</b> = fragments of wall recorded Feb 2000 &amp; photos.  <b>striped</b> = complete solid old walls probably surviving from when area was a walled orchard.  <b>solid</b> = rebuilt walls of old stone set back from original position to create footpath in front of 1960s dwellings.</p>

**Dimensions**  
Length: 3.22 m  
Height: 1.58 m  
Thickness: 0.32 m at south end

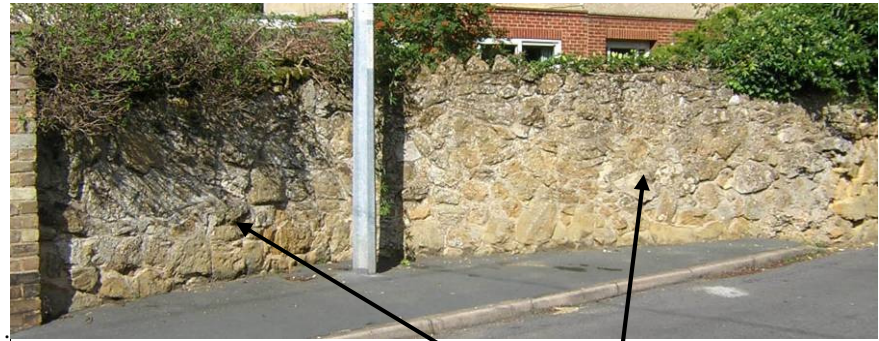
**VIEW OF WALLS 16B AND 16C**

<b>SECTION IV : WALL NUMBER 16C</b>		<b>Date Surveyed</b> February 2000
<b>Location/General Description</b> Front garden wall of 7a Little Lane, on west side of Little Lane		
<b>Construction</b> Random rubble stonework. Irregular lumps of sandstone decorating the top at intervals. Junction with wall 17 is rough and not vertical.		
<b>Composition</b> Predominantly sandstone. Occasional Barnack ragstone Brick	<b>Dimensions</b>  Length: 5.8 m  Height: 1.58 m  Thickness: n/k	
<b>Comments</b>

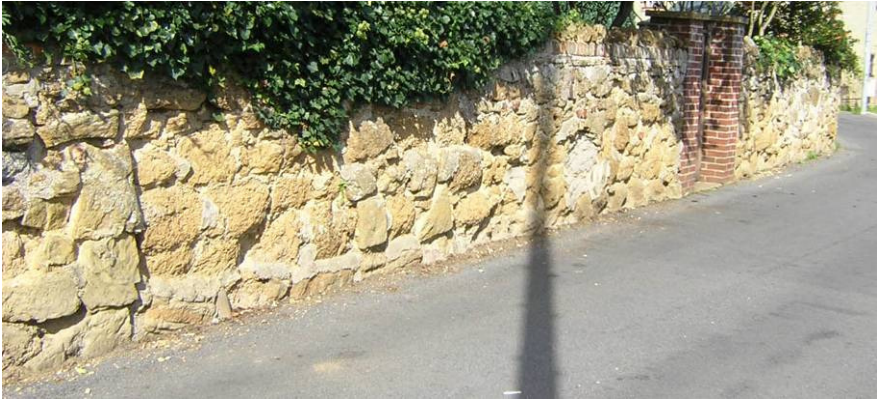
<b>VIEW OF WALL 17A</b>

<b>SECTION IV : WALL NUMBER 17A</b>		<b>Date Surveyed</b> February 2000
<b>Location/General Description</b> Boundary wall of 5A Little Lane, from 7A to pedestrian entrance to 5A. Part of the west boundary of Little Lane at the north end of its North-South section.		
<b>Construction</b> Random rubble stonework. Medium to large sandstone blocks with smaller stones and occasional brick towards top. Top made level with more bricks and capped with a course of bricks and decorated with lumps of sandstone.		
<b>Composition</b> Predominantly local sandstone. 15 Large stones Barnack ragstone (a few pieces) A course of brick on edge.	<b>Dimensions</b>  Length: 7.88 m  Height: 1.62 m - 1.8 m (see comments)  Thickness: 0.45 m	
<b>Comments</b> Height to top of stone 1.41 m, to top of bricks below soldier course 1.51 m, to top of soldier course 1.62, to top of decorative stones 1.8 m.

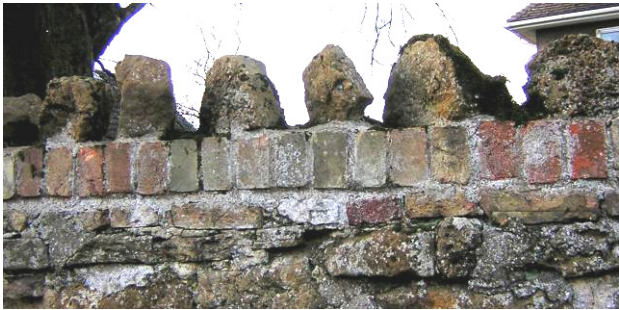
<b>DETAIL OF TOP OF WALL</b>

<b>SECTION IV : WALL NUMBER 17B</b>		<b>Date Surveyed</b> February 2000
<b>Location/General Description</b> Boundary wall of 5A Little Lane, from pedestrian entrance to vehicle entrance to 5A.		
<b>Construction</b> Random rubble stonework. Medium to large sandstone blocks with smaller stones and occasional brick towards top. Larger sandstone blocks at vehicular entrance end and more like 17C. Three courses of pre 1725 brick at top of part towards vehicle entrance but none in part towards pedestrian entrance. First 1.2m from pedestrian entrance has an eroded brick course on top of a layer of tile. Similar construction to 17A but more eroded and in poorer condition. Last 0.64m is of brick to form a straight edge for the brick gate pillar.		
<b>Composition</b> Predominantly local sandstone. 11 large stones Some Barnack ragstone – more than in 17A Brick including a brick on edge course. Tile	<b>Dimensions</b>  Length: Total 11.87 m (see comments)  Height: 1.55 m - 1.82 m (see comments)  Thickness: 0.45 m

<b>Comments</b> Length of wall – from S to N: 5.87 m for section without brick on top (including 1.2m of brick course), 5.36 m for section with brick on top, 0.64 m for brick end. At base of brick end there are three ridge tiles cemented flat onto surface of wall. Height at pedestrian entrance end: 1.6 m, with decorative stone 1.82 m. Height at vehicular entrance end: 1.36 m to start of brick layer, 1.55m to top of wall (excluding decorative stone), height to top of tallest decorative stone 1.8 m

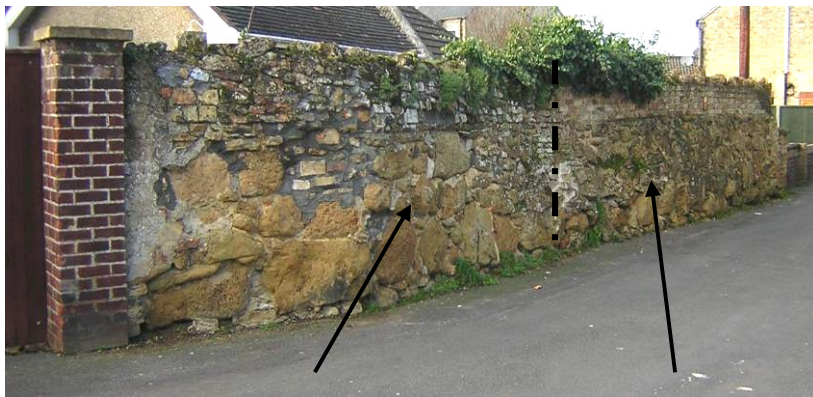
**Wall 17 C** **Wall 17 D**  
**VIEW OF WALL 17 C AND 17 D**

**Construction**  
Similar to previous part of wall, but with fewer decorative blocks at the top. No decorative stone for last 0.5 m. Some repairs/repointing with thick grey mortar.

<b>Composition</b>	<b>Dimensions</b>
Sandstone, 12 large stones. Bricks – a few in wall and several in top 500 mm Tiles in top 500 mm	Length: 5.98 m  Height: Total 1.75 – 1.91 m stone topping 0.16 m (where present)  Thickness: n/k

**Comments**  
Quite badly eroded, especially in lower part of wall – perhaps from de-icing salt. One sandstone is 1 m across the diagonal.

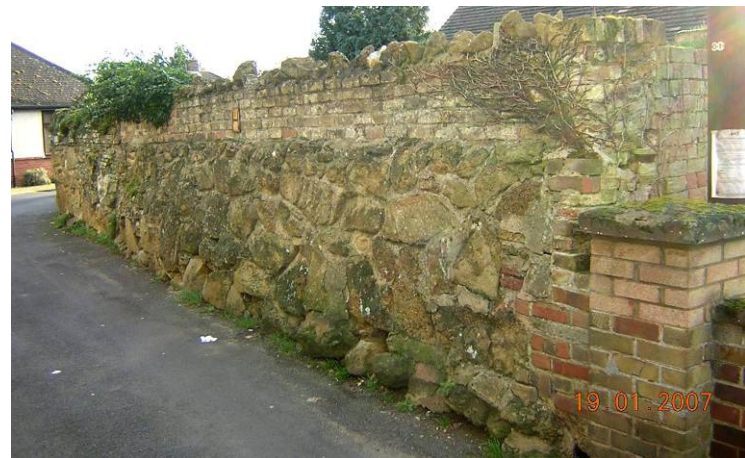
**VIEW OF WALL 17D**

<b>Composition</b>	<b>Dimensions</b>
90% Sandstone. Approximately 19 large stones. Brick	Length: 8.72 m  Height: Total 1.7 to 1.9 m Of stonework 1.35 to 1.45 m  Thickness: n/k

**Comments**  
Quite badly eroded, especially in lower part of wall – perhaps from de-icing salt. Sandstone blocks similar size to wall 17C.

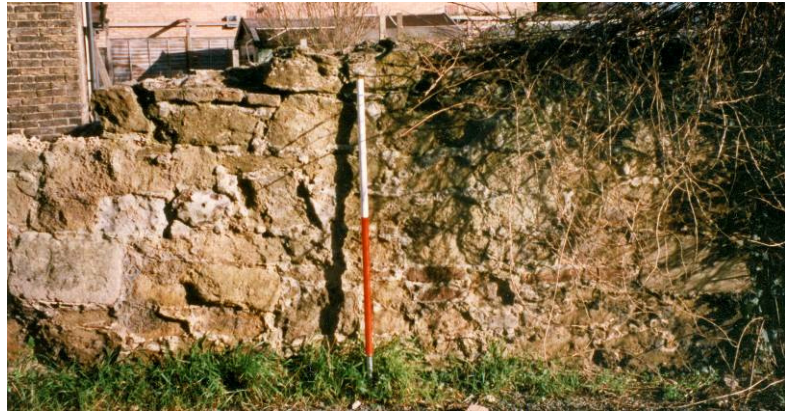
**VIEW OF WALL 18**

**Location/General Description**  
 Small fragment of decayed stone wall on north side of East-West section of Little Lane, opposite 2 Little Lane. possibly part of structure shown on 1888 OS map. By April 2003 replaced by perimeter fence of garden of new structure 19 Hills Lane and entrance to new house and garage at 1 Little Lane

<b>Composition</b>	<b>Dimensions</b>
Predominantly sandstone A few ashlar-cut Barnack ragstone pieces Red tile Thin red brick	Length: approx. 3.5 m  Height: Max approx 1.3 m  Thickness: approx 0.35 m

**Comments**  
 Much overgrown with brambles; land and wall neglected. Wall had been removed between Feb 2000 and April 2003. Dimensions are estimates based on photograph and information from local resident

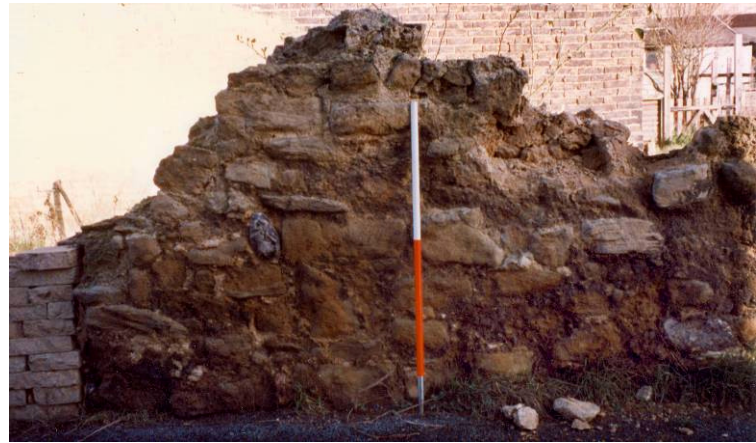
**VIEW OF WALL 19**

**Comments**  
 Removed between Feb 2000 and April 2003. Dimensions are estimates based on photograph and information from local resident

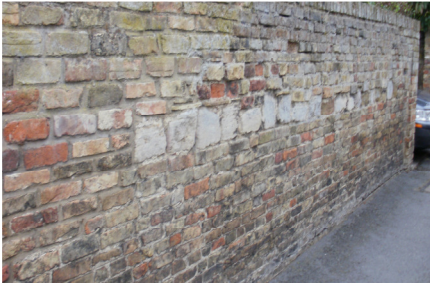
<b>VIEW OF PART OF WALL 22</b>

<b>SECTION IV : WALL NUMBER 22</b>		<b>Date Surveyed</b> May 2005
<b>Location/General Description</b> Garden wall of 66 St Mary's Street, located on west side of Cromwell Road		
<b>Construction</b> Single row of even-sized stones in brick wall, also a separate stone of oolite in a different course at south end, by gate.		
<b>Composition</b> 13 Barnack ragstones, ashlar cut but much worn. One of ragstones a pink colour. 6 sandstones 1 oolite (separate from main row) The bricks below and above the stonework are pre 1725.	<b>Dimensions</b>  Length: overall 8.8 m brick 2.97 m stone 5.5 m brick 0.76 m  Height: from ground to base of stone 0.88 m, to top of stone 1.07 m  Thickness: n/k	
<b>Comments</b> Single oolite 0.83 m from ground to base of stone, to top of stone 0.94 m.		
<div style="display: flex; align-items: center; justify-content: center;"> <div style="margin-right: 10px;">S</div> <div style="display: flex; align-items: center; gap: 10px;"> <div style="border: 1px solid black; width: 20px; height: 10px; background-color: #ccc;"></div> <div style="border: 1px solid black; width: 20px; height: 10px; background-color: #ccc;"></div> <div style="border: 1px solid black; width: 20px; height: 10px; background-color: #ccc;"></div> <div style="border: 1px solid black; width: 20px; height: 10px; background-color: #ccc;"></div> </div> <div style="margin-left: 10px;">N</div> </div> <div style="display: flex; align-items: center; justify-content: center;"> <div style="margin-right: 10px;">0</div> <div style="border: 2px solid black; width: 100px; height: 10px; background-color: black;"></div> <div style="margin-left: 10px;">5</div> <div style="margin-left: 10px;">SCALE in metres</div> </div>

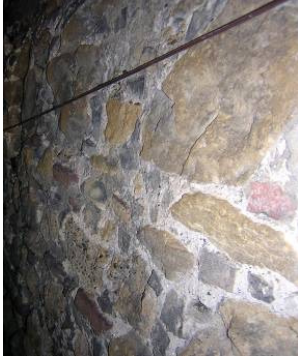
<p style="text-align: center;"><b>VIEW OF PART OF WALL 23A</b></p>	<b>Dimensions</b>  Length: 23A n/k 23B 0.6 m 23C 2.9 m  Height: 23A approx 1.6 m 23B 1.1 m (N) to 0.6 m (S) 23C 0.55 m (N) to 0.45 m (S) Thickness: 23A n/k 23B 0.45 m 23C 0.5 m to 0.85 m

<b>SECTION IV : WALL NUMBER 23</b>		<b>Date Surveyed</b> January 2004
<b>Location/General Description</b> Western wall of 48 West End, on north side of road. A newish house incorporating a stonewall in the lower part of its western wall (23A), which protrudes towards the street (23B), finishing as a rockery (23C).		
<b>Construction</b> 23A and 23B of rubble construction with outer face trimmed fairly level. Thin mortar on face. The centre of 23B is filled with mortar and small stones. The rockery (23C) is constructed of medium-sized sandstone pieces stacked up loosely, backed on the west side by concrete slabs cemented upright.		
<b>Composition</b> Predominantly sandstone.

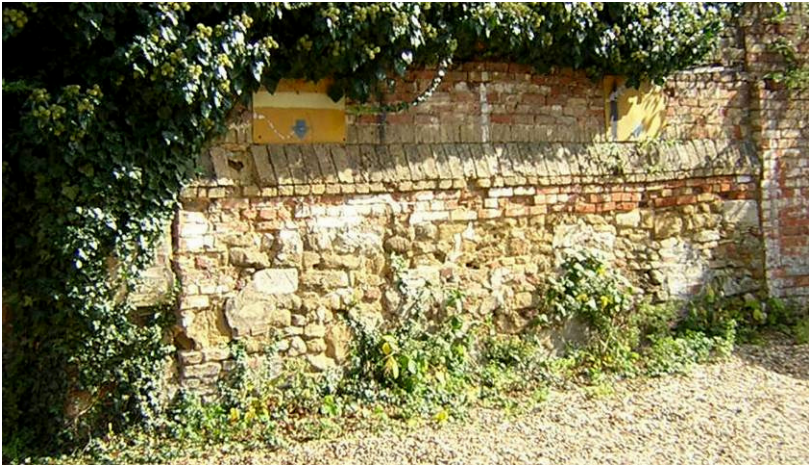
<b>VIEW OF WALL 26</b>

<b>SECTION IV : WALL NUMBER 26</b>		<b>Date Surveyed</b> May 2005
<b>Location/General Description</b> Barn Mews, at north end of alley between 88 St Mary's Street and the block containing 82-86 St Mary's Street. East side of Barn Mews forming side garden wall of St Mary's Street premises (probably 78 and 80). North end abuts, but is not connected to, wall 25.		
<b>Construction</b> Above the stone are 4 courses of brick (pre 1725) in English bond. Then there is a course of sloping flat faces of brick (23 cm x 11 cm) as thickness of wall narrows, then a header course. Above this are some 13 courses of bricks.		
<b>Composition</b> 2 Barnack ragstone, ashlar-cut Sandstone, rough blocks 2 nodular flints Fieldstone – red Midland quartzite? Brick Tile	<b>Dimensions</b>  Length: 5.16 m  Height: 1m of stone  Thickness: n/k	
Composition more mixed than walls 24 - 25.		
<b>Comments</b> Small patches indicate wall may once have been painted white. Brick is largely red rather than the white of wall 25

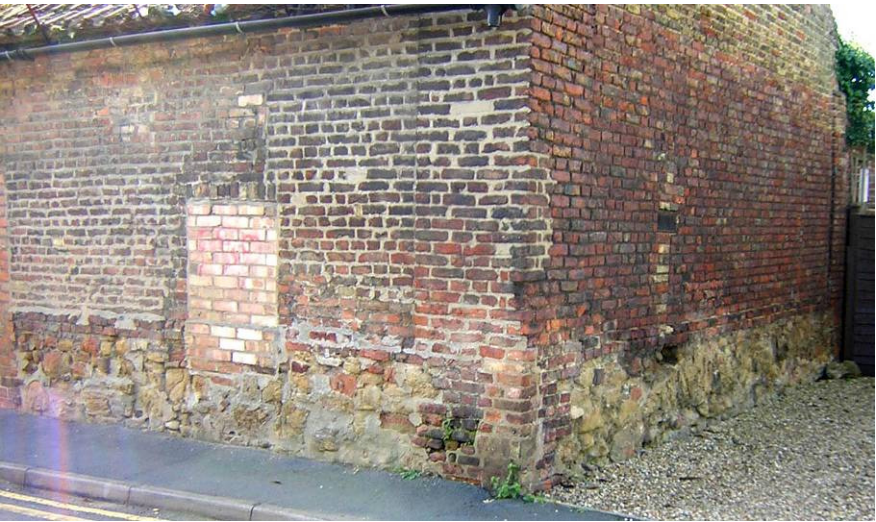
<b>WALL 27 B</b>		<b>WALL 27 A</b>

<b>SECTION IV : WALL NUMBER 27A</b>		<b>Date Surveyed</b> May 2005
<b>Location/General Description</b> North-West wall of Old Barn, Cromwell Road (Gable end).		
<b>Construction</b> Brick building with stone in lower 0.72 m of wall. Closely packed sandstone with minimum mortar		
<b>Composition</b> Sandstone, some pieces with grit inclusions, and 5 large stones. 1 Kimmeridge Clay concretion 1 Tabular flint 5 pieces of brick Pre 1725 brick above the stonework.	<b>Dimensions</b>  Length: 6.3 m of stone 0.4m brick to front  Height: 0.72 m  Thickness: n/k	
<b>Comments</b> One very red sandstone is probably burnt.

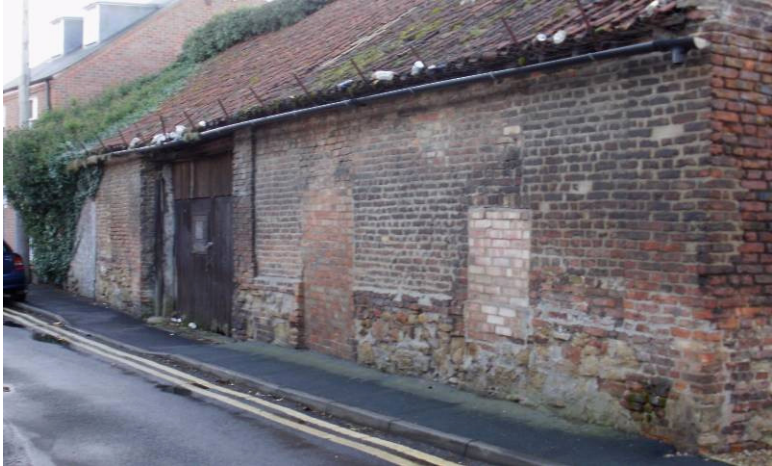
<b>VIEW OF WALL 27B</b>

<b>SECTION IV : WALL NUMBER 27B</b>		<b>Date Surveyed</b> February 2000	
<b>Location/General Description</b> Street frontage of Old Barn, Cromwell Road			
<b>Construction</b> Brick building with stone in lower courses. Closely packed sandstone with minimum mortar. Stone areas divided by central doorway into two, and then into panels by brick. Infill of smaller doorway by brick.			
<b>Composition</b> Sandstone, some pieces with grit inclusions. 3 Barnack ragstone 1 Kimmeridge Clay concretion 1 Tabular flint 1 fieldstone - partially decayed schist Pre 1725 brick above the stonework. Assorted brick		<b>Dimensions</b> Length: 18.75 m including doorway  Height: total 3.0 m stone courses 0.75 m  Thickness: n/k	
<b>Comments</b>  One of Barnack ragstones and 7 of sandstones are pinkish/reddish and probably burnt. Last 2m of wall at south-east end is possibly all brick, but this could not be confirmed as is obscured by ivy.

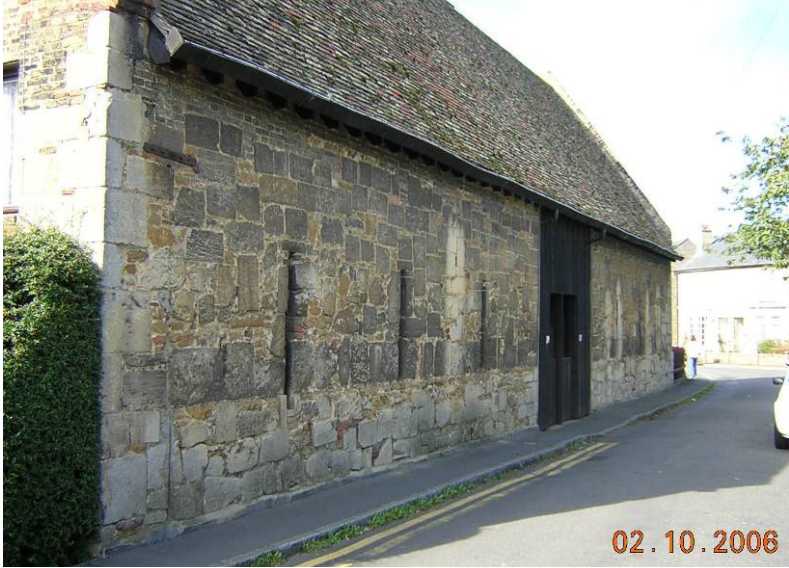
<b>VIEW OF WALL 28</b>

<b>SECTION IV : WALL NUMBER 28</b>		<b>Date Surveyed</b> February 2000	
<b>Location/General Description</b> Restored 17 <sup>th</sup> century barn forming 17 and 19 Cromwell Road (now called North Barn and South Barn respectively).			
<b>Construction</b> Mainly large blocks of re-used dressed stone, with thick mortar containing small stone inclusions. Wide central doorway with three slit windows on either side. About six courses of pre 1725 brick at eaves level.			
<b>Composition</b>  Wall fronting onto Cromwell Road: Barnack ragstone, large blocks Sandstone Brick  There are some stone mouldings.		<b>Dimensions</b>  Length: 22.85 m including doorway 9.6 m SE of doorway 9.55 m NW of doorway  Height: 3.6 m  Thickness: n/k	
<b>Comments</b> A notice on the wall records "This 17C barn was converted into houses by the East Cambridgeshire District Council in 1977".

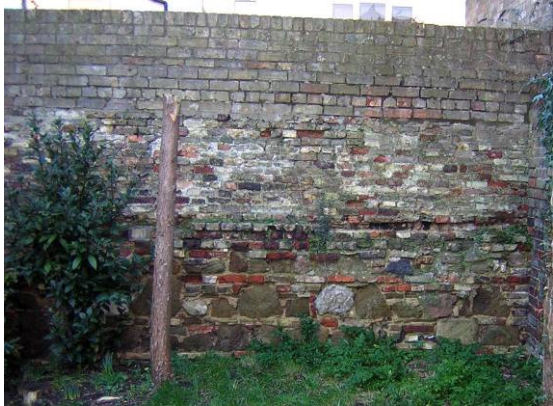
<b>SECTION IV : WALL NUMBER 29</b>		<b>Date Surveyed</b> February 2000
<b>Location/General Description</b> Back garden wall of 62 St Mary's Street		
<b>Construction</b> Basically a brick wall with some stone inserts. The lowest courses of construction containing stone, appear to be wider than the upper brick courses.		
<b>Composition</b> 40 % Sandstone Barnack ragstone Oolite Kimmeridge clay concretion Fieldstone – dark igneous Flints – medium sized tabular 30 % brick (pre 1725). Tiles	<b>Dimensions</b>  Length: 4.46 m total 4.26 m stone  Height: 0.85 m to top of stone + three courses of brick  Thickness: n/k	
<b>Comments</b>

Wall partially hidden by vegetation.
<b>VIEW OF WALL 29</b>

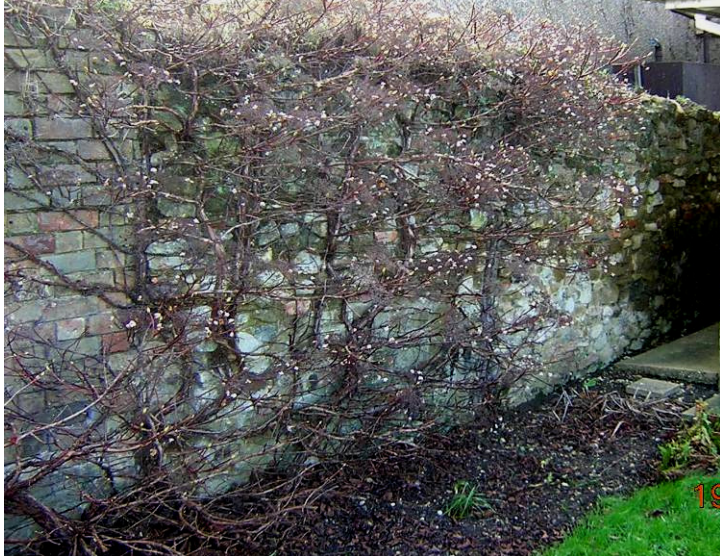
<b>VIEW OF WALL 30</b>

<b>SECTION IV : WALL NUMBER 30</b>		<b>Date Surveyed</b> May 2006
<b>Location/General Description</b> Front garden wall of 2 Little Lane on east side (see wall 15 for location map).		
<b>Construction</b> Roughly-coursed Barnack ragstone and sandstone with some brick. North end of wall is 4.1 m from street frontage.		
<b>Composition</b> 20 % Barnack ragstone, re-used ashlar. 40 % Sandstone 10 % Brick Some flint 1 piece possibly Purbeck marble. There are 2 shaped stones.	<b>Dimensions</b>  Length: 7.6 m  Height: 1.8 m  Thickness: 0.35 m at top	
<b>Comments</b> Partially obscured by vegetation.

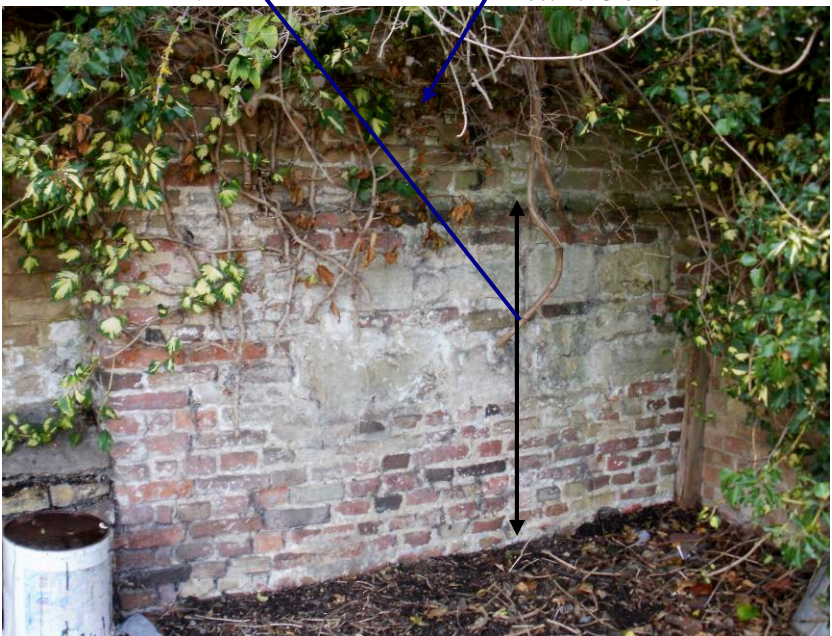
<b>SECTION IV: WALL NUMBER 32</b>		<b>Date Surveyed</b> October 2009
<b>Location/General Description</b> Part of west garden wall to 40 West Fen Road		
<b>Construction</b> This wall is a continuation of walls 33, 34 and 35 and is similar in construction to wall 33.		
<b>Composition</b> (inner face) 45 % post 1725 brick (in top 1 m) 35 % pre 1725 brick 20 % Stone including Barnack limestone and local sandstone.	<b>Dimensions</b>  Length: 2.5 m (to junction of wall 33)  Height: 2.21 m (to underside of coping)  Thickness: n/k	
<b>Comments</b>

<p>1.2 m Post 1725 brick</p>		
<b>VIEW OF WALL 32</b>
