Ely & District Archaeological Society

# A SURVEY OF STONE WALLS IN ELY

Sections I -V Complete

# **SURVEY OF WALLS IN ELY**

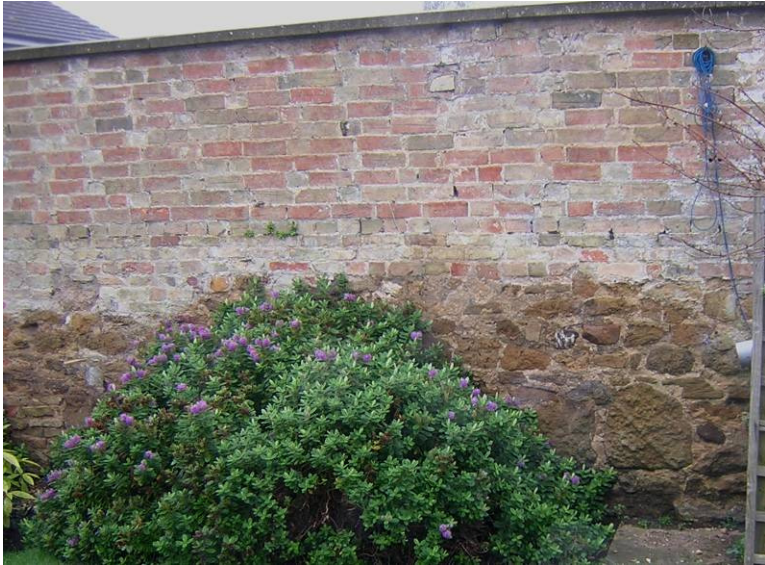
<b>VIEW OF PART OF WALL 34, SECTION B</b>

<b>SECTION IV: WALL NUMBER 34</b>		<b>Date Surveyed</b> January 2008
<b>Location/General Description</b> Back garden wall of May House, St Catherine's (west boundary wall).		
<b>Construction</b> The wall can be divided into two sections: <b>A</b> to the south being predominantly brick and Section <b>B</b> being brickwork on random rubble stonework.		
<b>Composition</b> (inner face) Section <b>A</b> 95% pre 1725 brickwork 5% various, including stone at ground level Section <b>B</b> 11 courses of brickwork on: 70% local sandstone (incl. 4 or more large pieces). 20% brick, including terracotta coping stones. 5% Barnack rag. 5% various, including flint.	<b>Dimensions</b> Section <b>A</b> <b>B</b> Length: 4.2 m    10.7 m  Height: 2.3 m    2.4 m  Thickness: n/k	
<b>Comments</b> The wall is partially obscured by vegetation and some modern construction. The wall continues on either side into adjacent gardens.

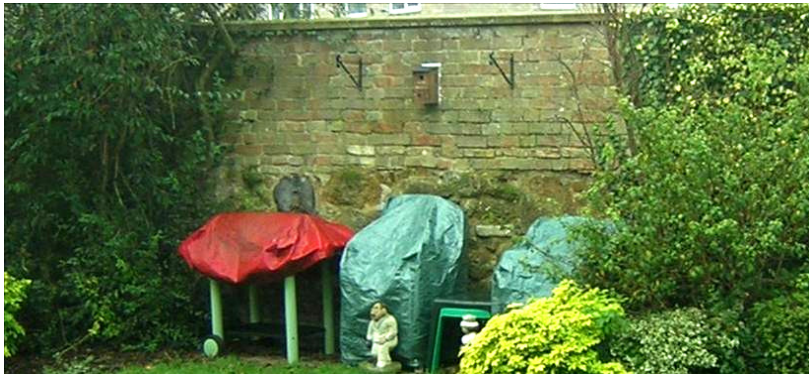
<b>VIEW OF PART OF WALL 35</b>

<b>SECTION IV: WALL NUMBER 35</b>		<b>Date Surveyed</b> January 2008
<b>Location/General Description</b> Rear garden wall of 1A St Catherine's (west boundary wall).		
<b>Construction</b> Brickwork on random rubble stonework, with a concrete coping.		
<b>Composition</b> (inner face) 12 courses of brickwork on: 90% local sandstone. 10% various, including Barnack limestone, brick and flint ( with 1 large piece)	<b>Dimensions in meters</b>  Length: 14.8 m  Height: 2.3 m o/a 1.3 m of stonework  Thickness: not known	
<b>Comments</b> Approximately half of the wall was hidden behind vegetation and garden furniture. The wall continues approximately 1 m into the neighbouring garden on the north.

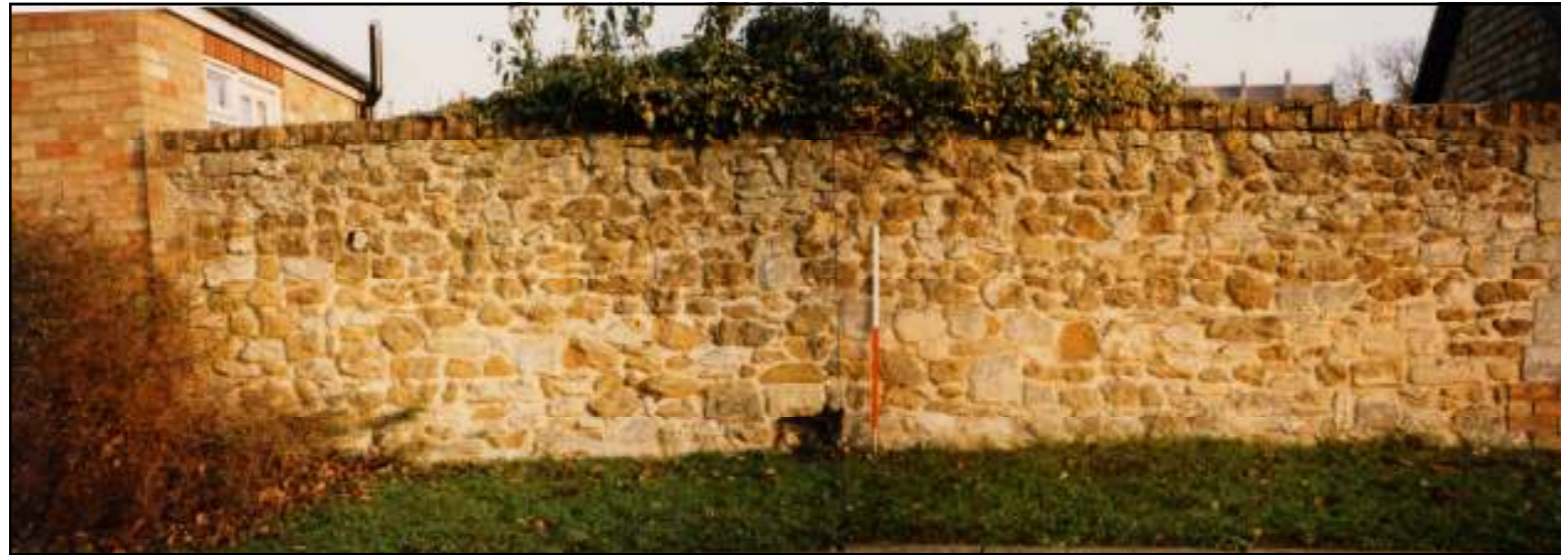
Figure : V 20. Barton Road

<b>SECTION V : WALL NUMBER 20</b>		<b>Date Surveyed 8 Jun 1995</b>
<b>Location/General Description</b> West side boundary wall of no 13 Barton Road.		
<b>Construction</b> Roughly coursed. South end finished with dressed Barnack ragstone (2 pieces at bottom replaced by brick), after which the wall is of brick. Single row of brick at top.		
<b>Composition</b> About equal amounts of sandstone and oolite 1 tile, red outer black inner 1 yellow tile Sandstone conglomerate 1 chalk Orange-brown field stone (quartzite?) Dressed Barnack ragstone (in body as well as at end)	<b>Dimensions</b>  Length: 6.9 m stone extending to 10.85 m with brick  Height: 1.6 m stone; 1.73 m brick  Thickness: not known	
<b>Comments</b>		
<b>Wall 21</b>

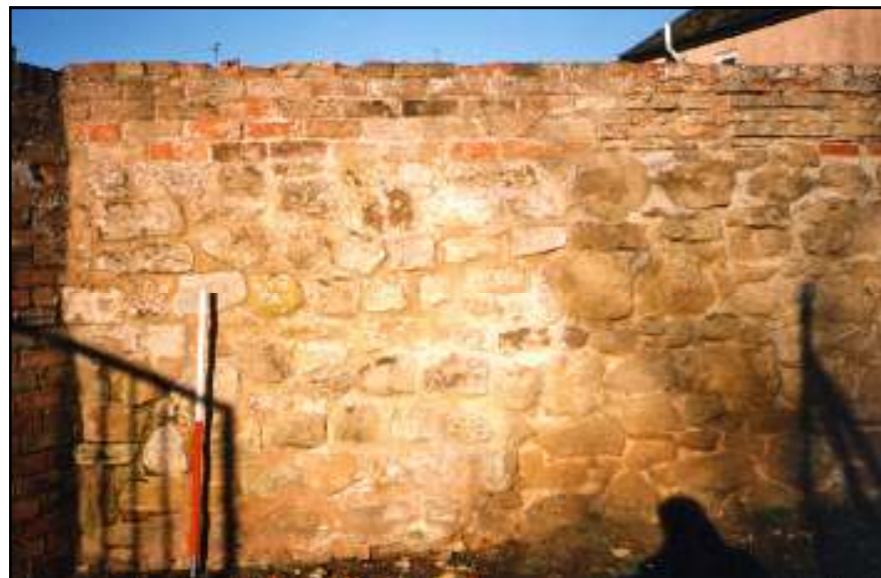
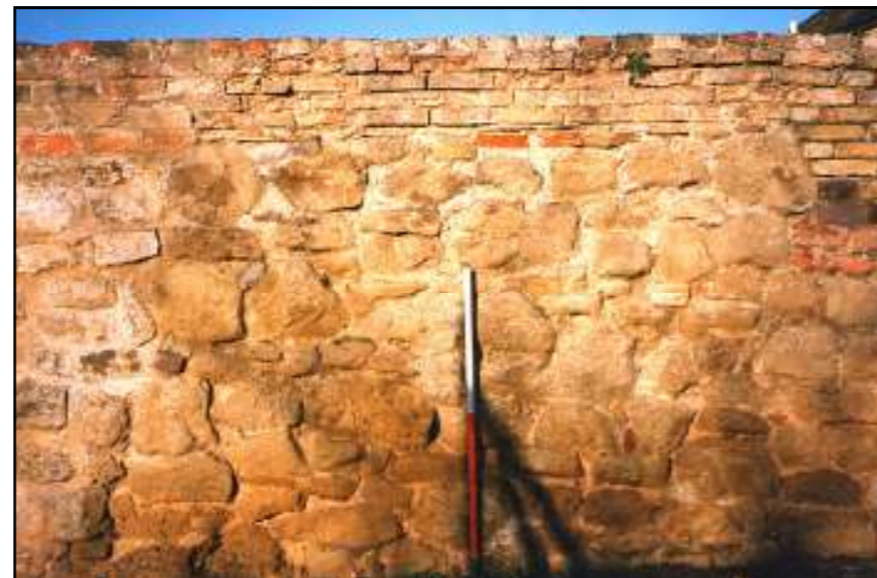
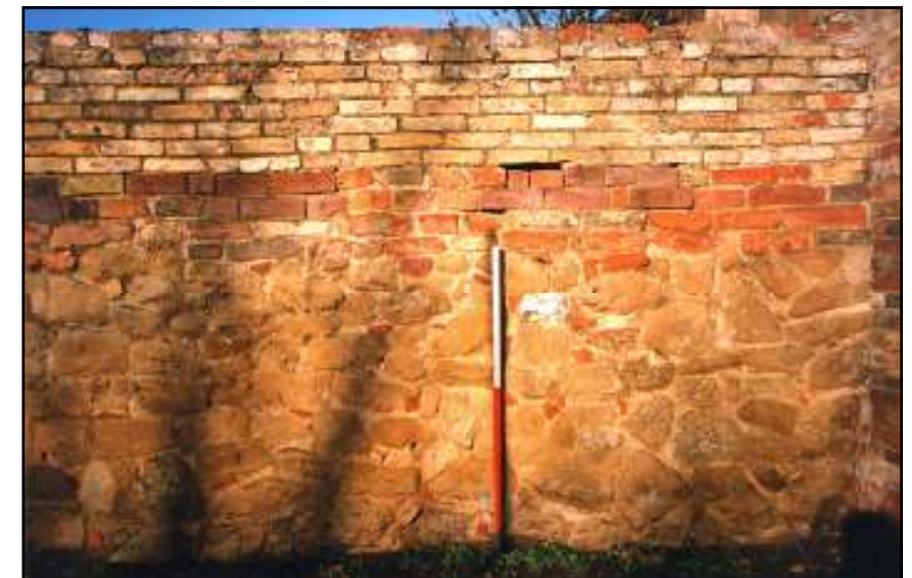
<b>SECTION V : WALL NUMBER 7</b>		<b>Date Surveyed 4 Jun 1995</b>
<b>Location/General Description</b> Boundary wall on East side of Church Lane, next door to No 3 Church Lane.		
<b>Construction</b> Roughly coursed. Bottom coursing more uniform than top. Area of brick at top of North end of stretch of wall. Wall is capped with brick. Tiles/pot are all at north end of wall.		
<b>Composition</b> Barnack ragstone Sandstone, about three-quarters Sandstone conglomerate Glazed tile or broken pot (Near-black glazing, red body) Tiles (red outer layer, black body) Brick	<b>Dimensions</b>  Length: 6.8 m  Height: 1.7 m max to 1.35 m min  Thickness: 0.44 m	
<b>Comments</b> Tiles project from wall, demonstrating erosion of the stone. Mosses and lichens predominantly at the top of the wall (? effect of traffic, ? different light/moisture levels) and mostly on conglomerate (? due to better purchase for plants).
